Near-miss: Exposed live electrical cable

Safety Flash Published on 4 April 2013 Generated on 25 April 2025 IMCA SF 05/13

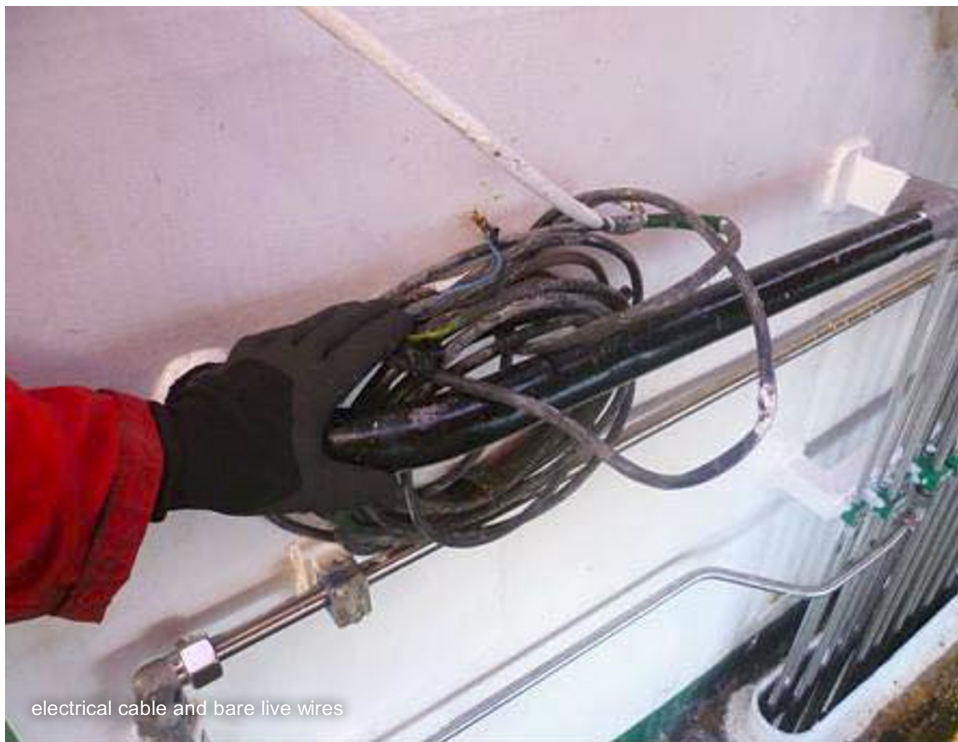
A member of the crew working near the new hyperbaric lifeboat noticed an electrical cable which was coiled up and stowed between a handrail and an adjacent bulkhead. The ends of the cable were not terminated but had been separated and wrapped up in electrical insulating tape. It was noted that a small amount of smoke was coming from the end of the cable and some sparking (the cable was in contact with the bulkhead). Realising that the cable was live the crewman immediately contacted the deck electrician and asked him to come and investigate. The electrician subsequently traced the cable and made it safe. The cable was identified as the supply to a halogen flood light originally intended as overboard illumination for the launch station of the vessel's FRC.

- There had been inadequate planning and inadequate supervision of the work.
- The old flood lamp had been removed with no Permit To Work (PTW) or Electrical Isolation (EI) certificates in place.

- Owing to the high workload of vessel staff and the large number of jobs being undertaken simultaneously, there had been a failure of control, in that it had not been possible for ship's officers to observe all tasks and thus ensure that vessel policies were followed.

- There was no evidence to suggest that any communication was made to ship yard fitters that live electrical supplies were still present within their work area.

- There had been inadequate planning ahead of the job being undertaken; not all power supplies in the work area were assessed or isolated.
- All services that were required to be isolated and removed prior to the area being handed over to the third party contractor for the installation of the HLB had been successfully completed. The requirement to remove the overboard light was not part of this original scope of work.

- The third-party contractor deviated from their original work scope and removed the flood lamp without the necessary PTW and EI in place.
- The third-party contractor did not follow the Management of Change procedure.

- The induction to the vessel during dry dock is to be reviewed and will include additional information regarding the Management of Change procedures
- The use of a single point of contact for each work area was not in place while the vessel was in dry dock. This would have allowed the third-party contractor to approach their contact and arrange the necessary PTW and EI for the additional works they required.

- Although this work area still had additional works to be carried out, the area was not fully surveyed once the initial works had been completed prior to handover.
