Snubber failure

Safety Flash Published on 10 April 2014 Generated on 14 January 2025 IMCA SF 05/14

A member has reported the discovery of a failure to a snubber on an ROV launch and recovery system.

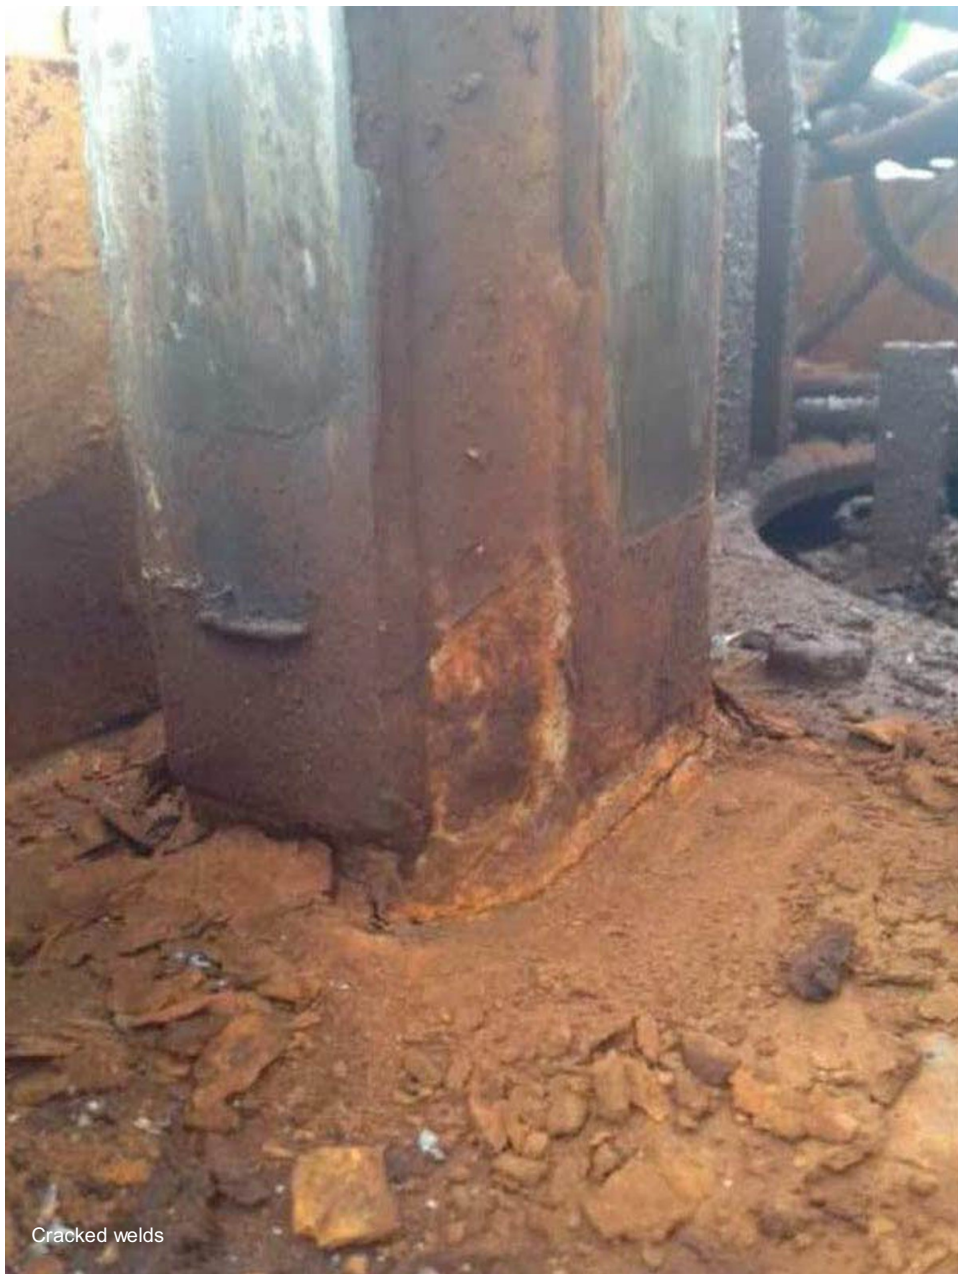
This was discovered during maintenance and annual load test of the ROV. When the tether management system (TMS) was separated from the ROV to facilitate maintenance work, this highlighted that the snubber did not appear to be sitting level. Upon investigation, it was found that the starboard snubber guide runner had detached from the snubber. Whilst this did not prevent the snubber function from operating, it did result in the snubber not maintaining its level when operating. On closer inspection, the port side snubber guide runner was found to have cracked welds also. The failed items were not associated with the load path and therefore there was no risk of dropped objects.

The incident emphasises the need for thorough inspections during 'routine' maintenance tasks in order to capture any damage, fatigue or abnormalities.

- Cleaned and prepared area for repair and welding.
- Close visual inspection of the other ROV onboard the vessel. No cracked welds were observed, but the welding was reinforced as a contingency.
- Added a six monthly visual inspection of the snubber assembly to company preventative maintenance system.
