Fatal incident during change-out of chain wheel (gypsy) on anchor handling tug supply (AHTS) vessel

Safety Flash Published on 2 April 2015 Generated on 24 January 2025 IMCA SF 05/15

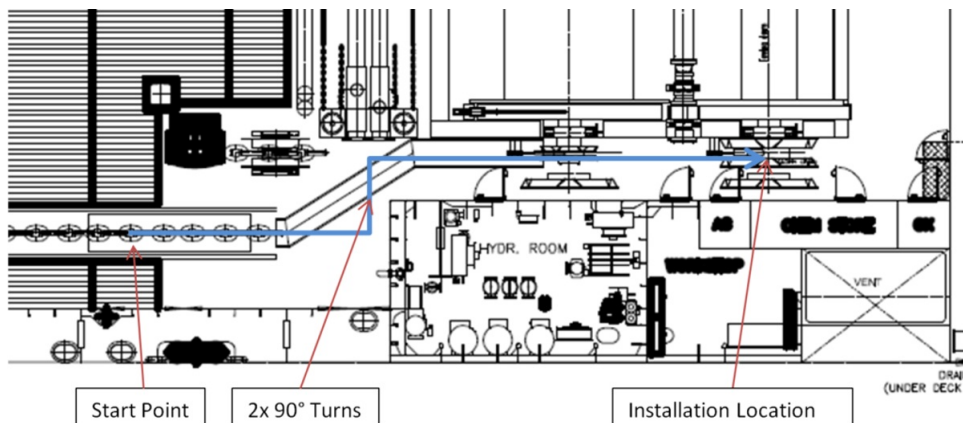
The crew disconnected the gypsy wheel from the crane without checking its final landing position. Therefore, they did not see that the rims of the gypsy wheel were on each side of the skid rail for the chain lifter. Immediately after disconnecting from the crane, the crew started to roll the gypsy wheel. This resulted in the starboard rim dropping into the gap in the rail causing the gypsy wheel to tip beyond balancing point. It fell over and pinned two crew members against the bulkhead. This resulted in one fatality and one first aid case.

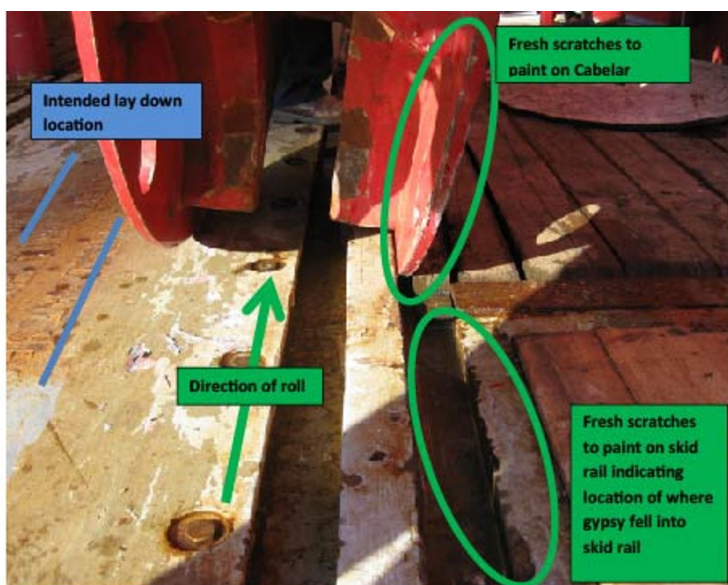
- Gypsy wheel rolled into skid rail causing it to tip over.
- Lack of risk management:
 - Failure to identify hazards and risk.

the cause of the gypsy wheel tipping over (in photo above, the term 'cabelar' is used as well as 'gypsy')

- Company-wide instruction forbidding free-rolling of these heavy items.
- Technical task force to evaluate a safe method for the installation of gypsy wheels in the short and long term and review change out methods across the fleet.
- All vessels to review and re-risk assess current methods for handling gypsy wheels and submit risk assessment for approval.
