## Dropped object from crane

Safety Flash Published on 13 February 2020 Generated on 3 July 2025 IMCA SF 05/20

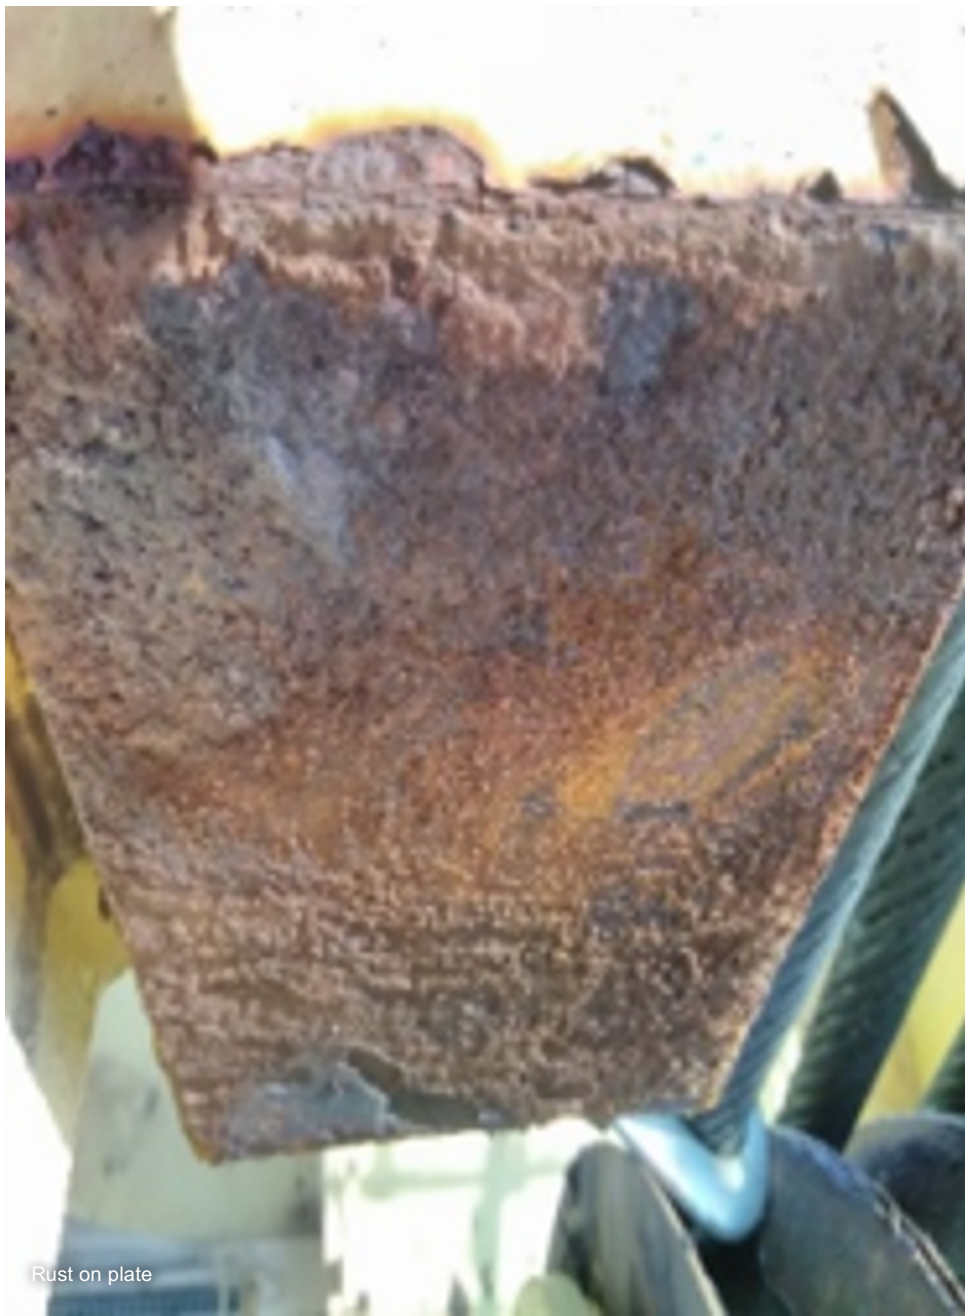
A composite block forming the end stop topping of a crane fell 20 m from the crane to deck. The incident occurred after a Suez Canal transit, when it had been necessary to use the crane to lift a small boat into and out of the water. After clearing the canal, the crane had to be secured for sea. While slewing to the right, the composite block (end stop topping) fell from the top of the crane (a height of 20 m). A number of crew members were within 4 m of where it landed. No-one was injured.

Stopper missing

Investigation revealed that the composite block was only glued instead of drilled and fastened to the crane. Rust came in between the steel plate of the crane and the composite block, which loosened it and caused it to fall off.

- Check your own cranes for loose or potentially loose objects and for rust and corrosion and consider engineered solutions to any potential problems identified.
- Consider the area immediately around the crane to be a potential dropped object zone.
- Conduct a fresh dropped object survey on the vessel.
