## Dropped object near miss – Crane boom bumper stop falls off

Safety Flash Published on 13 February 2020 Generated on 21 January 2025 IMCA SF 05/20

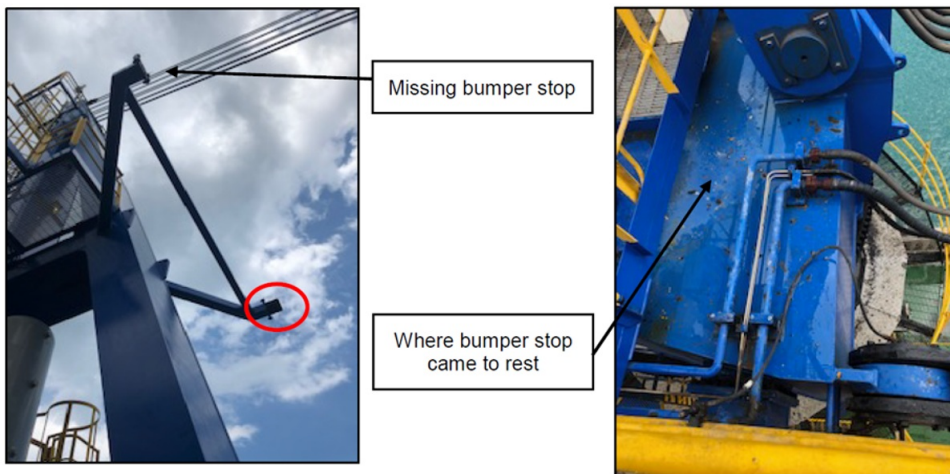
The incident occurred during preparation for vessel reactivation following a period in warm stack; a crane mechanic spotted a part of one of the vessel cranes had fallen off and was missing.

The crane mechanic stopped his inspection and proceeded up the crane to investigate further. The bumper stop was observed laying on the crane cab level outside of the handrails. The bumper stop is made of vulcanised rubber that is bonded to a steel securing plate and fitted to the crane A frame with steel bolts. A steel wire secondary securing lanyard was fitted around the circumference of the vulcanised rubber and tied back to the A frame. The vulcanised rubber had detached from the steel securing plate which remained attached to the A frame; however, the secondary securing wire had corroded and parted allowing the bumper stop to fall.

- The vulcanised rubber section of the bumper stops was vulnerable to UV light damage.
- Secondary retention wires should be manufactured from a corrosion resistant material.
- The location and lack of accessibility to the bumper stops prevented regular and sufficient physical inspection:
  - The condition of the bumper stops and the secondary retention device could not be fully assessed without scaffolding, rope access or alternative means.
  - The secondary retention wire was not clearly visible from the closest point of inspection 2m away. Degradation of the wire could not be seen.
  - The vulcanised rubber section of the bumper stop had deteriorated to an unstable condition and detached from the securing plate.
- There is potential for similar incidents to happen on other vessels, in areas where access to potential dropped objects is difficult.

- Continue existing dropped object inspections, and review existing dropped object checklists and/or work orders when next used and update if required.
- Identify equipment and structures that cannot be easily accessed for inspection and present a risk of dropped objects and determine the best means of safe access and frequency of inspection.
- Ensure exposed potential dropped objects are suitably protected from corrosion and ensure retention devices are of suitable strength and made from corrosion resistant material.
- Investigate the use of an alternative bumper stop material that does not degrade in sunlight and consider other components that are vulnerable to UV

damage that could result in an incident.

- Consider if inspection or replacement frequency needs to be increased.
