Dropped object near miss – Crane boom bumper stop falls off

Safety Flash Published on 13 February 2020 Generated on 28 January 2026 IMCA SF 05/20

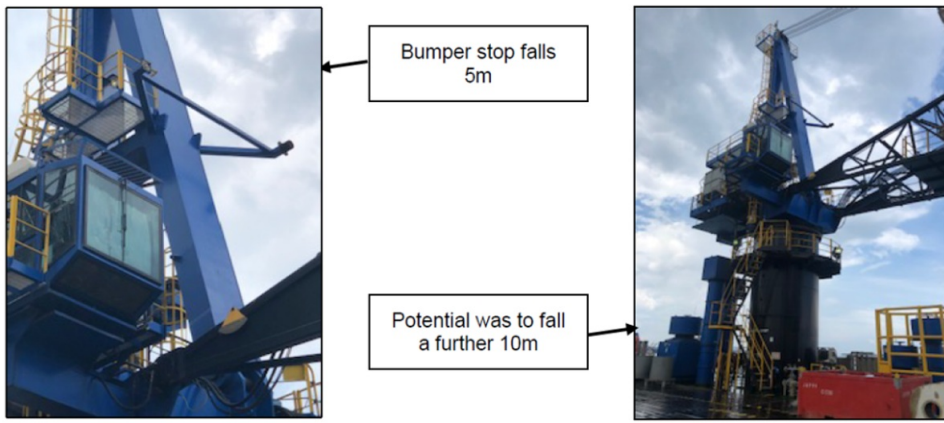
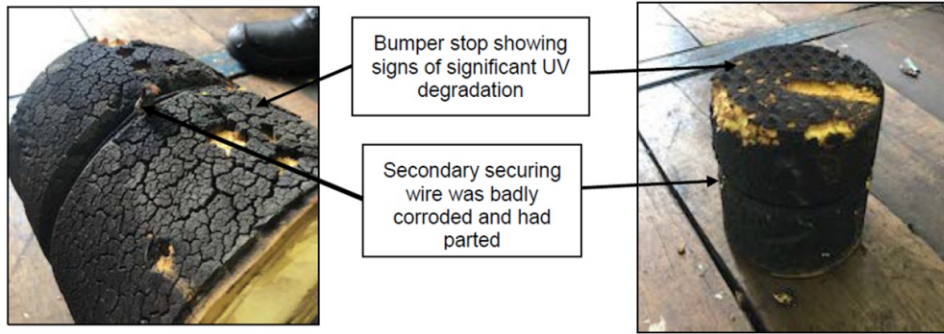
The crane mechanic stopped his inspection and proceeded up the crane to investigate further. The bumper stop was observed laying on the crane cab level outside of the handrails. The bumper stop is made of vulcanised rubber that is bonded to a steel securing plate and fitted to the crane A frame with steel bolts. A steel wire secondary securing lanyard was fitted around the circumference of the vulcanised rubber and tied back to the A frame. The vulcanised rubber had detached from the steel securing plate which remained attached to the A frame; however, the secondary securing wire had corroded and parted allowing the bumper stop to fall.

- The vulcanised rubber section of the bumper stops was vulnerable to UV light damage.
- Secondary retention wires should be manufactured from a corrosion resistant material.
- The location and lack of accessibility to the bumper stops prevented regular and sufficient physical inspection:
 - The condition of the bumper stops and the secondary retention device could not be fully assessed without scaffolding, rope access or alternative means.
 - The secondary retention wire was not clearly visible from the closest point of inspection 2m away. Degradation of the wire could not be seen.
 - The vulcanised rubber section of the bumper stop had deteriorated to an unstable condition and detached from the securing plate.
- There is potential for similar incidents to happen on other vessels, in areas where access to potential dropped objects is difficult.

- Continue existing dropped object inspections, and review existing dropped object checklists and/or work orders when next used and update if required.
- Identify equipment and structures that cannot be easily accessed for inspection and present a risk of dropped objects and determine the best means of safe access and frequency of inspection.
- Ensure exposed potential dropped objects are suitably protected from corrosion and ensure retention devices are of suitable strength and made from corrosion resistant material.
- Investigate the use of an alternative bumper stop material that does not degrade in sunlight and consider other components that are vulnerable to UV

- damage that could result in an incident.
- Consider if inspection or replacement frequency needs to be increased.
