Crane whip line parted during hook stop testing

Safety Flash Published on 11 February 2021 Generated on 12 January 2025 IMCA SF 05/21

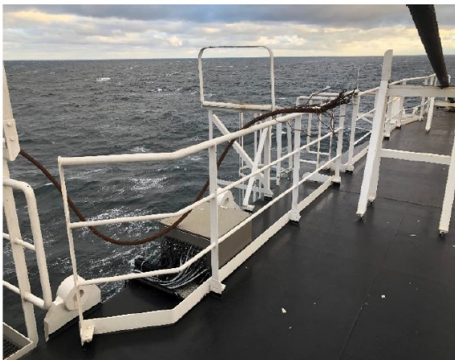
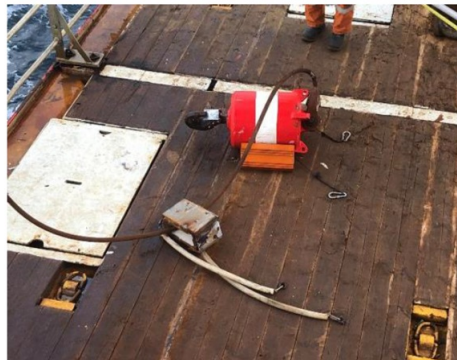
An uncontrolled hoisting movement resulted in the headache ball striking the jib and falling with the hook stop rigging assembly back to deck.

The Crane Operator was testing both the main winch and the auxiliary winch. The main winch was tested and operated normally. When the Crane Operator started to test the auxiliary winch, the winch accelerated to full speed pulling the headache ball into the sheave. The headache ball collided with the jib and the wire snapped, approximately 19 metres from the headache ball. The headache ball (500 kg) and the hook stop rigging (25 kg) dropped 4.2 metres to deck. There were no personnel in the vicinity.

- The winch was actuated by two hydraulic motors and the speed of the motors measured by encoders. The encoders were badly corroded inside and within the circuit board which resulted in erroneous signal being sent. Both speed encoders required replacement. The crane software was updated to include a second barrier preventing wrong signals from the encoder.
- The winch wire was in poor condition, corroded and dry. The investigation identified deviations from the wire rope management requirements of both the company and the owner of the vessel.
- The auxiliary winch wire was the original wire installed on the winch and had been in service for approximately 7.5 years. Magnetic Rope Tests (MRT) were performed every second year with wire cut-back completed in accordance with the recommendations from the examination. The latest MRT was not

completed successfully due to failure in the test equipment and was overdue at the time of the incident. The wire used was 2160 grade which is vulnerable to brittleness; the company does not accept this grade if it is avoidable.

- The risk for using the wire had been identified - however, it was not supported by a Management of Change (MoC) and risk assessment and so no corrective action taken.

- Check and see if this same encoder component fault can occur on your worksite and check the maintenance routines for encoders.
- Further assure the integrity of wire ropes by carrying out a thorough visual examination combined with either annual Destruction Test or MRT Traces.
- Identify the age of the wire ropes and confirm appropriate in-service reviews have been carried out.
- Ensure formal MoC process is followed where compliance with existing procedures is not possible.
- Review risk assessment for the crane start-up process and ensure that safe positioning of personnel and associated controls are an included control requirement.
