Fractured finger while handling metal plates

Safety Flash Published on 28 February 2022 Generated on 28 January 2026 IMCA SF 05/22

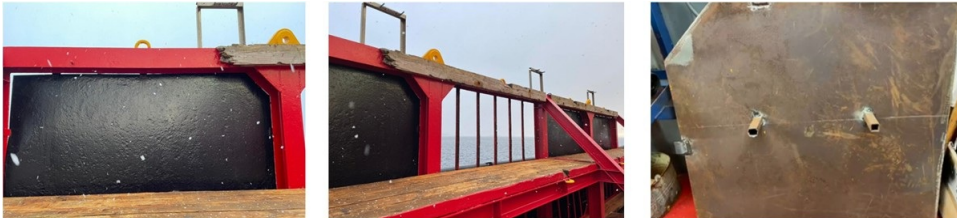
Heavy weather had caused damage to welded plates on deck. While manually handling the plate back into position with another crew member, the injured person suffered a pinch injury to his finger which was trapped between the plate and frame. Following a medical review, the vessel headed into port to permit further diagnosis at hospital. An X-ray showed a distal fracture to the tip of the finger and the wound required stitches.

- The design of the plate did not allow for safe manual handling.
- The installation of the plate had a permanent risk of finger entrapment.
- The risk assessments and toolbox talk used were generic in content and not task specific.
- The JSA used was for hot work only and did not include manual handling at all.

- Safety by design: the plate was subsequently modified to have a pair of temporary handles to keep fingers away from the pinch points.
- Magnetic lifting handles sourced as a long term solution.

- Take care with generic risk assessments – ensure they are either modified to suit the task, or use a dynamic risk assessment or toolbox talk specifically for a full and thorough review of the task.
- If the task is slow, uncomfortable or inconvenient, can we use the toolbox talk or JSA to better define and understand these areas of risk? Can we remove the risk or reduce its likelihood or severity?
