LTI: Finger crushed while moving mobile gantry crane

Safety Flash Published on 16 February 2023 Generated on 23 January 2025 IMCA SF 05/23

A crew member suffered a crushed index finger during manual handling of heavy equipment.

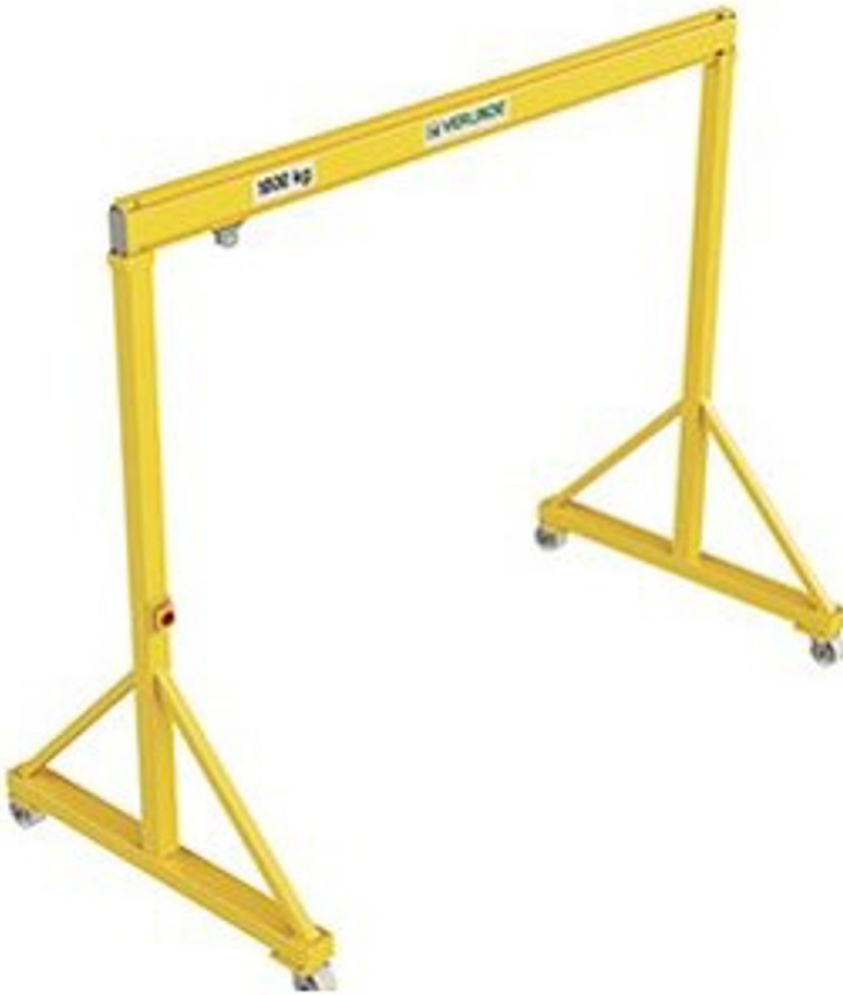
Fig. 1: Mobile gantry crane
(image: www.hoistuk.com/products/portable-mobile-gantry/)

- The company discontinued the use of this very heavy steel mobile gantry crane with no safety locks on the wheels, and replaced it with a new, much lighter Aluminium mobile gantry crane with wheel safety locks.
- Easier access between port and starboard deck areas was created by modifying (extending) the height of cable tray pipes to avoid the necessity of assembling/disassembling of the gantry crane before movement.
- Re-emphasised crew training on Permit to Work and Risk Assessment –

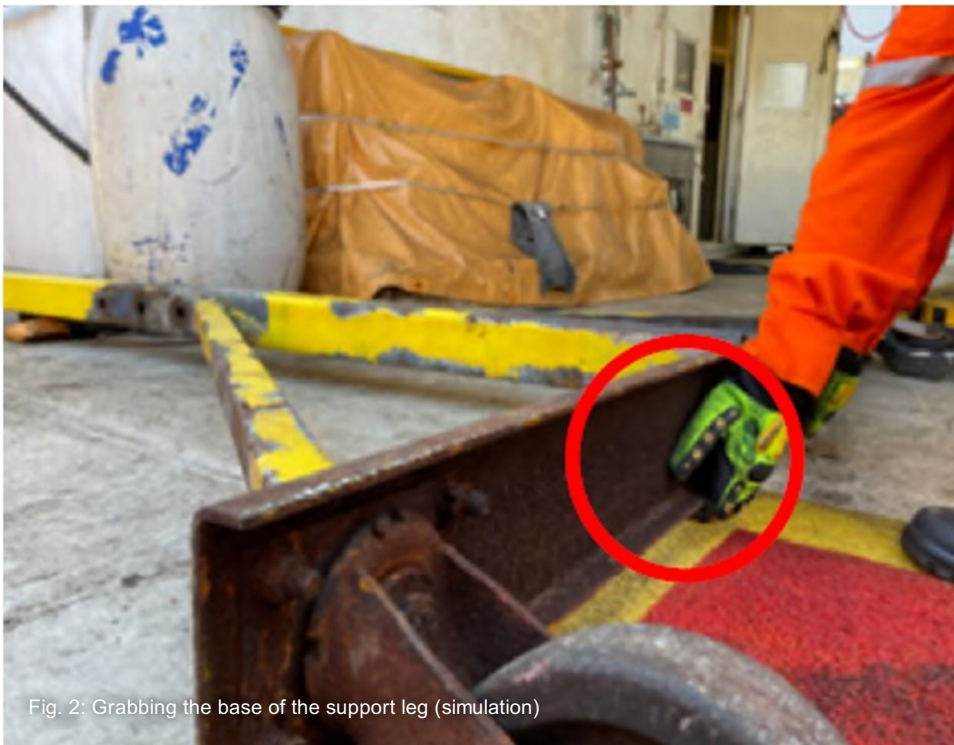
The injured person (the bosun) started dragging the first support leg, without waiting for help, by grabbing its base from below. As he did so, a vertically positioned wheel turned, causing the support leg to collapse onto his finger and crush it against the deck.

Fig. 2: Grabbing the base of the support leg (simulation)

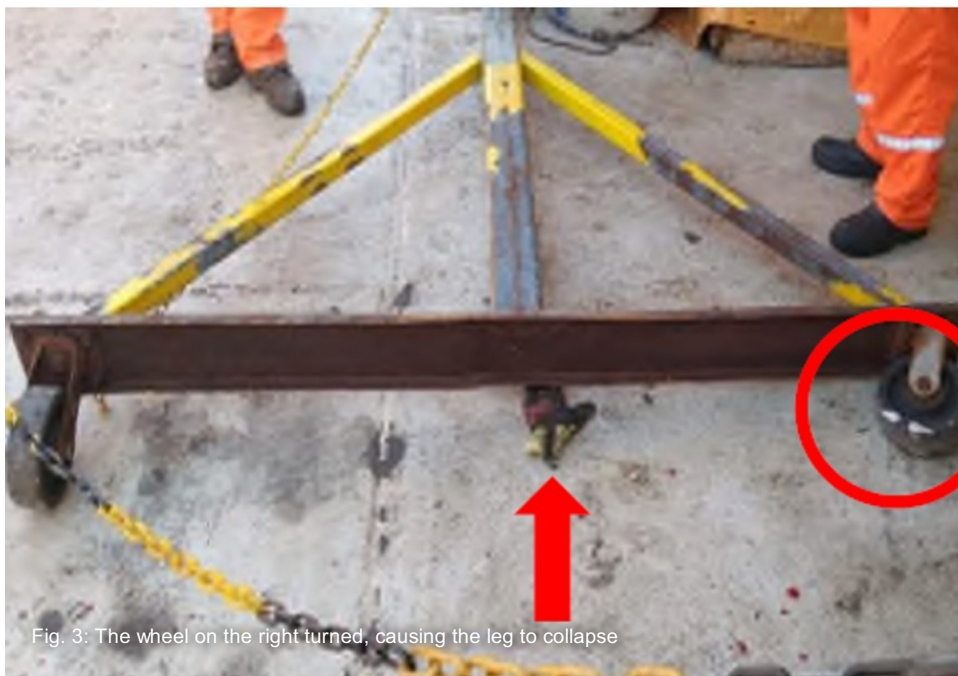
Fig. 3: The wheel on the right turned, causing the leg to collapse

- There was inadequate planning, lack of communication, lack of supervision, and lack of experience in handling manual loads.
- Company procedures were not followed: the Risk Assessment was inadequate. No account was taken of:
 - The weight of the gantry.
 - How many people would be needed to move it safely.
 - The technique to be used and the route through which the loads would be moved.
- **No-one stopped the job** – *“What are we doing here? Let’s just stop a moment and re-assess the situation...”*
- There was insufficient safety awareness of the considerable “line of fire” risks faced – no attention was paid to the pinch point risk.
