## Personnel lifting system fatality

Safety Flash Published on 1 October 2000 Generated on 28 January 2026 IMCA SF 06/00

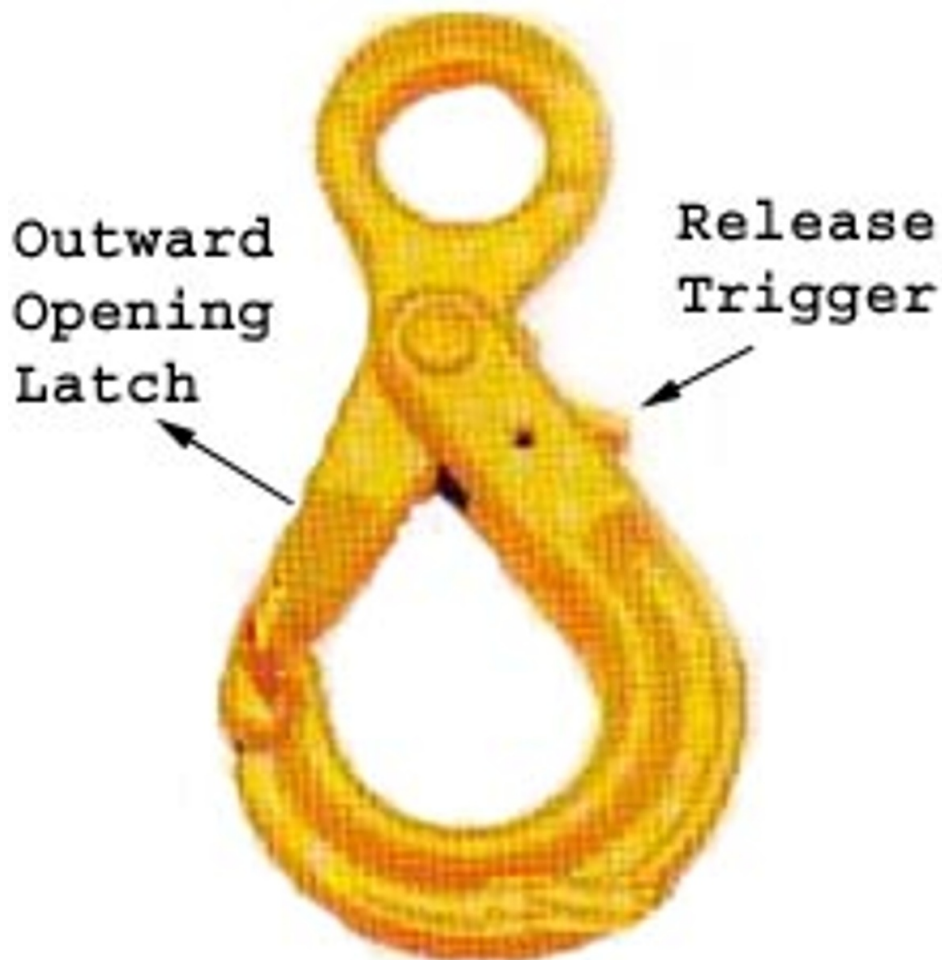
We have learned of a fatality when a worker fell from a full body harness boatswain's chair when ascending on a hoisting system.

The initial information from the investigation team indicates that the individual fell when he became detached from the self-locked grip latch hook, similar to that depicted below. The latch on the hook depicted on the right opens outward.

The company involved has implemented a survey of all personnel hoisting and fall arrest systems seeking:

- verification that all hook components are designed and manufactured and certified for lifting personnel.
- where such hooks are used, these should be self-locking and self-closing with an inward moving latch.
