Diver injury using cavitation blaster

Safety Flash Published on 30 July 2007 Generated on 17 January 2025 IMCA SF 06/07

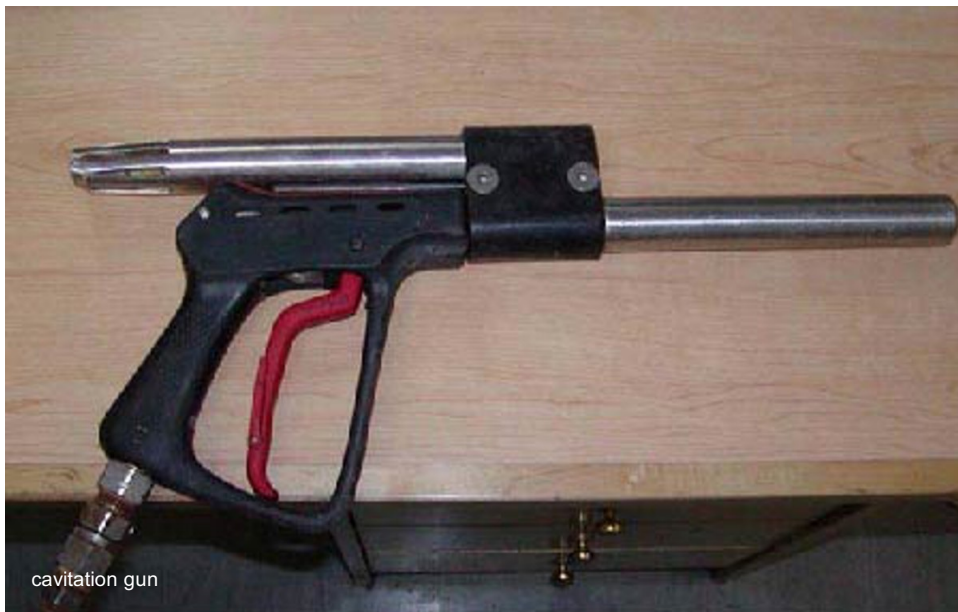
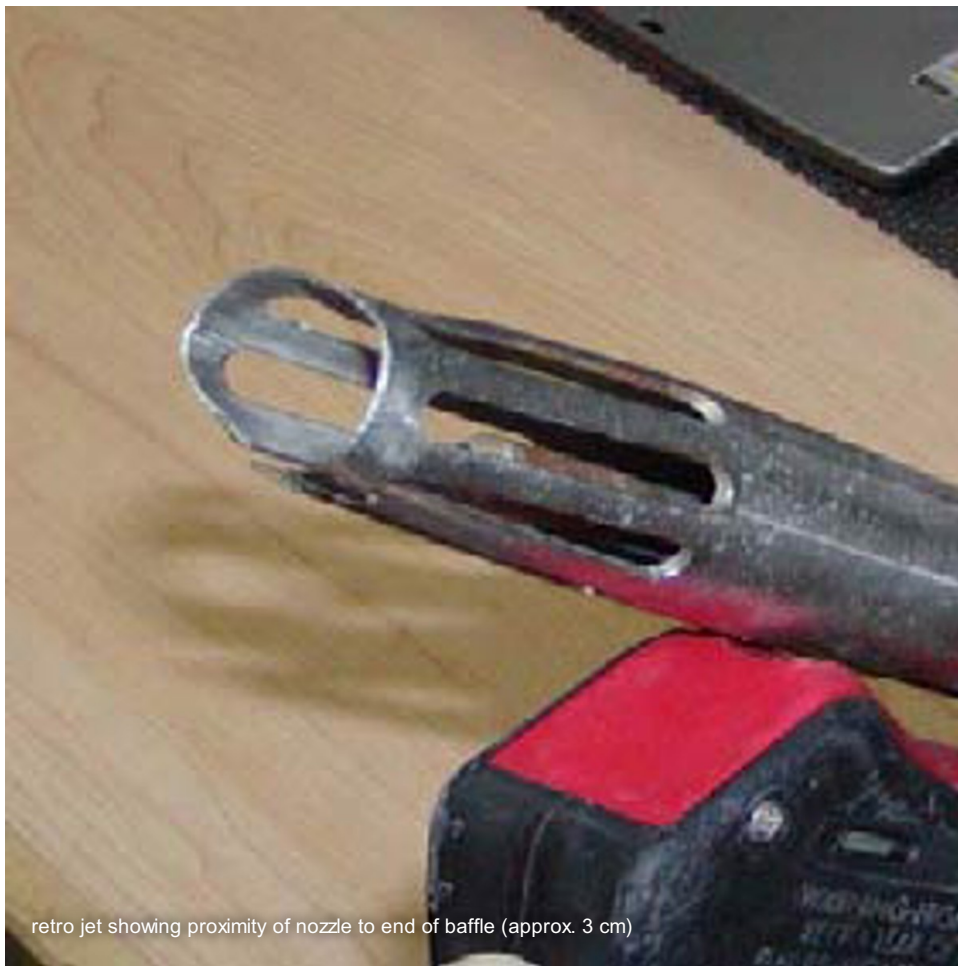
During marine growth removal operations the diver released the trigger on the cavitation gun to reposition his body. When the diver reapplied pressure to the trigger, the cavitation gun kicked back towards the diver, causing the retro end of the gun to come into close proximity of his wrist and forearm. The retro jet subsequently caused a high pressure (approximately 1000 psi) seawater injection injury to the diver's forearm.

The risk assessment had not highlighted the fact that the retro jet posed a high pressure injection risk to the diver.

The incident investigation discovered that the diver had not been wearing the 11 inch long butyl rubber gloves as recommended by the system manufacturer but it was unclear if wearing these would have prevented the injury.

The manufacturer has now modified the retro jet by moving the nozzle further back inside the rear baffle. The company involved will be carrying out a full examination of the modification before allowing the cavitation blaster back into use.
