Confined space – multiple fatalities

Safety Flash Published on 4 July 2011 Generated on 17 January 2025 IMCA SF 06/11

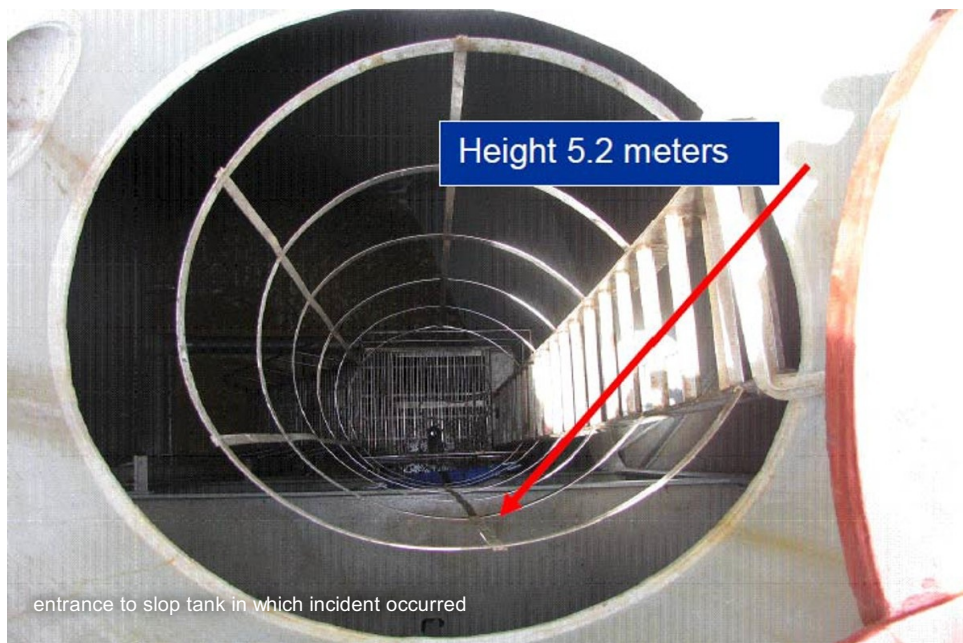
Shortly afterwards, personnel heard a noise as if an object had fallen into the tank. The chief officer came to the starboard slop tank and saw the bosun lying unconscious on the middle platform, 5.2 metres below the main deck. The chief officer immediately entered the tank with the intention of helping him. Further crew members arrived at the slop tank and saw the chief officer trying to wake the bosun up. Assistance and a stretcher was called for, and one crewman remained and then entered into the tank in order to help the chief officer.

All three persons became unconscious in the tank. Shortly thereafter the second officer started preparations for entering safely into the starboard slop tank. A portable fan was fitted to the slop tank in order to accelerate the ventilation. In the meantime the atmosphere inside the tank was measured by a portable gas analyser. The device went off to indicate the existence of H₂S in the tank. The read values were O₂: 20, CO: 0, H₂S: 60 and LEL: 0.

- The bosun had fallen into the slop tank for unknown reasons.
- The chief officer entered into the tank impulsively ignoring the safety rules completely and acting emotionally to help his colleague.
- The crewman also reacted emotionally rather than logically and entered the tank to assist the chief officer to rescue the bosun.
- The recovery operation, including identified the danger caused by the accumulated gas in the tank, the rescue of the victims from the tank, the application of the first aid treatment and the helicopter medevac was carried out successfully and professionally in accordance with company procedures.
- There was inadequate understanding of how this lethal concentration of H₂S had been produced in the slop tanks.
