Near-miss: Saturation diver lost gas supply

Safety Flash Published on 25 June 2012 Generated on 21 January 2025 IMCA SF 06/12

A member has reported a near-miss incident in which a saturation diver on the seabed lost reclaim and immediately thereafter, lost his main gas supply.

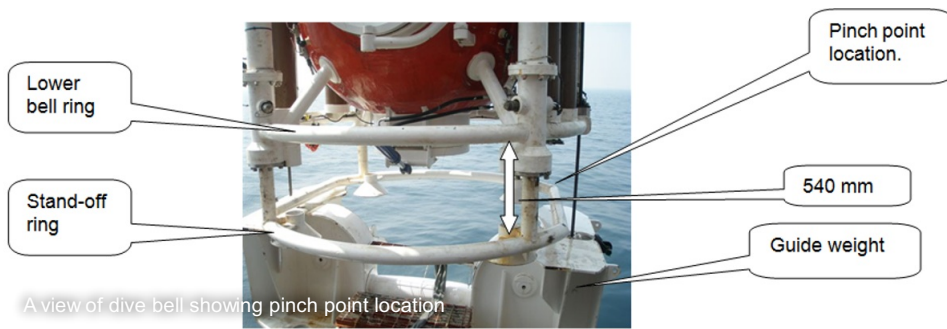
- There was no written procedure for setting the bell directly on the guide weight during dives.
- Egress from the bell was between the guide weight and the stand-off ring rather than between the stand-off ring and the lower bell ring.
- In-boarding of the bell launch and recovery system (LARS) resulted in a decrease in the gap between the guide weight and the stand-off ring which subsequently trapped the excursion umbilical to the extent that gas flow through all lines was interrupted. A video image of the gap area was available at the control panel of the LARS but not in dive control.

- A stand down and investigation was initiated prior to continuing diving operations.
- An enquiry was made to the system manufacturer as to the intended method of entry and exit from the bell¹. It was confirmed that the normal route was between the stand-off ring and the lower bell ring. The use of twin 12 litre cylinders with flotation attached impeded access through the designed route (540 mm). The bottom hatch opening is itself 700 mm. It was further agreed that the space limitation would compound matters in the performance of a rescue dive. For this reason the route chosen was not altered for the remainder of the project.

- Investigation as to the feasibility of modifications to increase the gap to 800 mm are on-going with the manufacturer and the owner.
- For subsequent dives a sign was posted at the LARS control console advising landing of the bell upon the guide weight while divers are locked out, with reminder to confirm with the Supervisor prior to any movement of the launch equipment while diving. A statement to this effect was included in written procedures and communicated throughout the company.
