## Near-miss incidents: Crew transfer vehicles approaching wind turbines

Safety Flash Published on 8 May 2015 Generated on 28 January 2026 IMCA SF 06/15

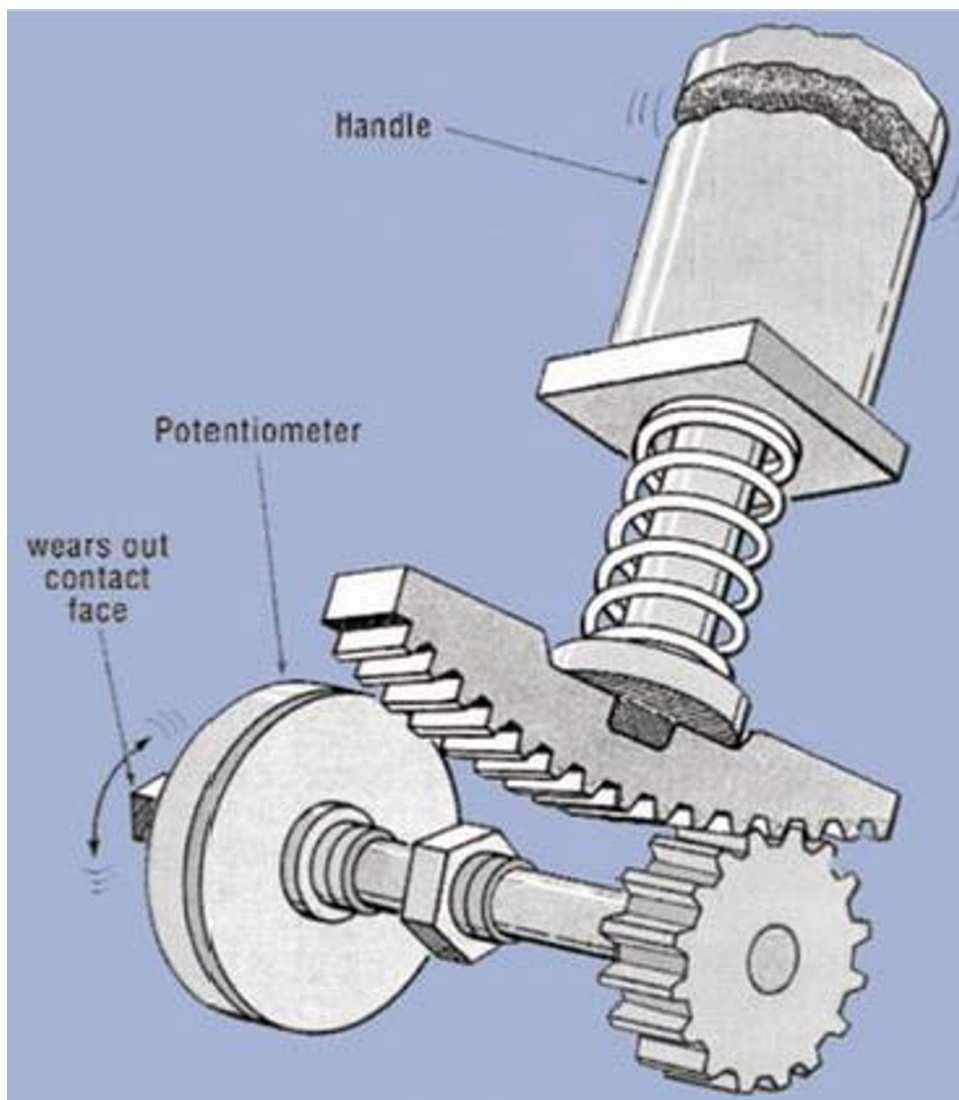
### **Incident 3 – Joystick potentiometer wear**

This incident is similar to incident 2 above. Within the previous week on another crew transfer vessel the Master noticed the vessel was not steering correctly when on passage to site. Suddenly the steering on both units would not centralise and was stuck hard to starboard, the jet display alarmed with fault code: JS steer fault (joystick).

The Master, under advice over the phone from the superintendent, removed the joystick from the fly bridge steering console and replaced it with the faulty unit in the wheelhouse. All steering was regained. The faulty unit was sent back to the supplier, and under investigation it was found that the steering potentiometers had worn. Our member considered introducing planned maintenance/replacement of such units to prevent recurrence.
