Near miss: Fire hazard arising from failed fuel pipe connection

Safety Flash Published on 21 March 2017 Generated on 22 January 2025 IMCA SF 06/17

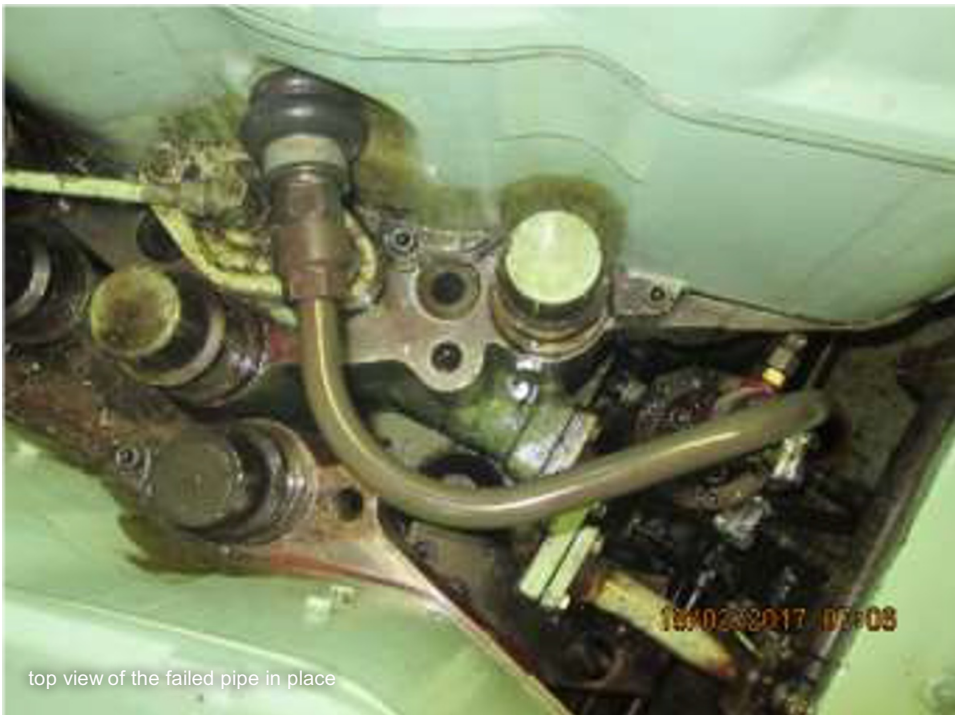
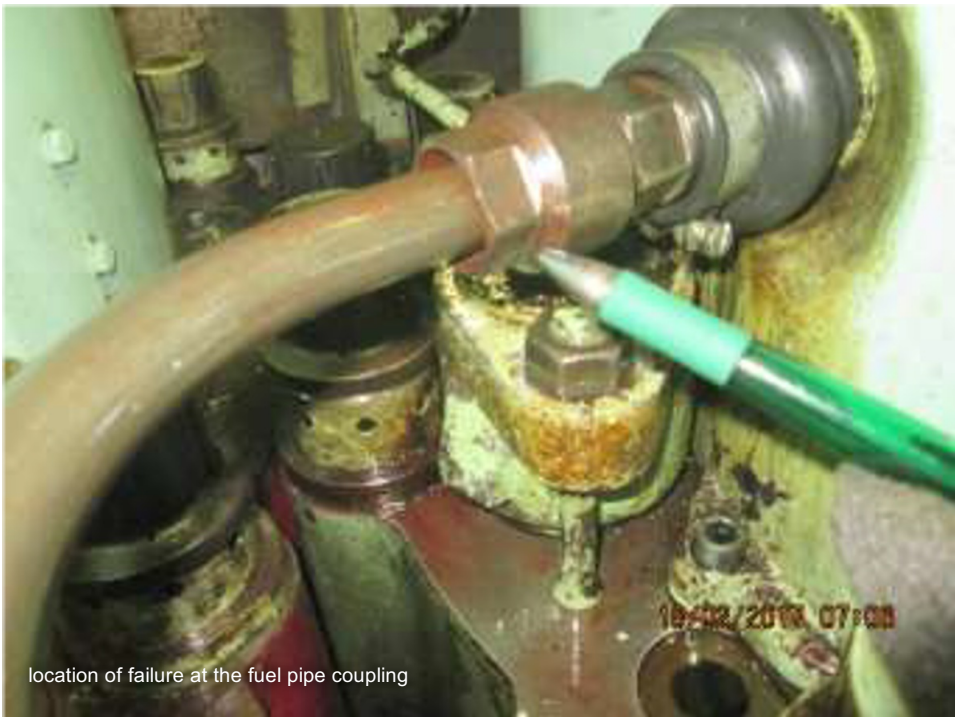
location of failure at the fuel pipe coupling

- The cause of the incident was a failed high pressure fuel pipe coupling between the fuel injector and delivery pipe. This caused fuel to run onto hot engine components which created smoke.
- The leak originated from the fuel coupling which contained an O-ring seal inside. Upon inspection the O-ring was not brittle or damaged.
- The pipe was inspected and showed no signs of visible damage. Further analysis would take place.

- Investigate similar systems to ensure no other latent failures or defects that may result in recurrence.
- Ensure main engine fuel pump overhaul to include fuel pipe pressure testing and seal renewals.
