## Electric shock near-miss

Safety Flash Published on 2 June 2009 Generated on 20 January 2025 IMCA SF 07/09

**A Member has reported an incident in which an employee sustained an electrical shock whilst re-routing a work class remotely operated vehicle (ROV) tether.**

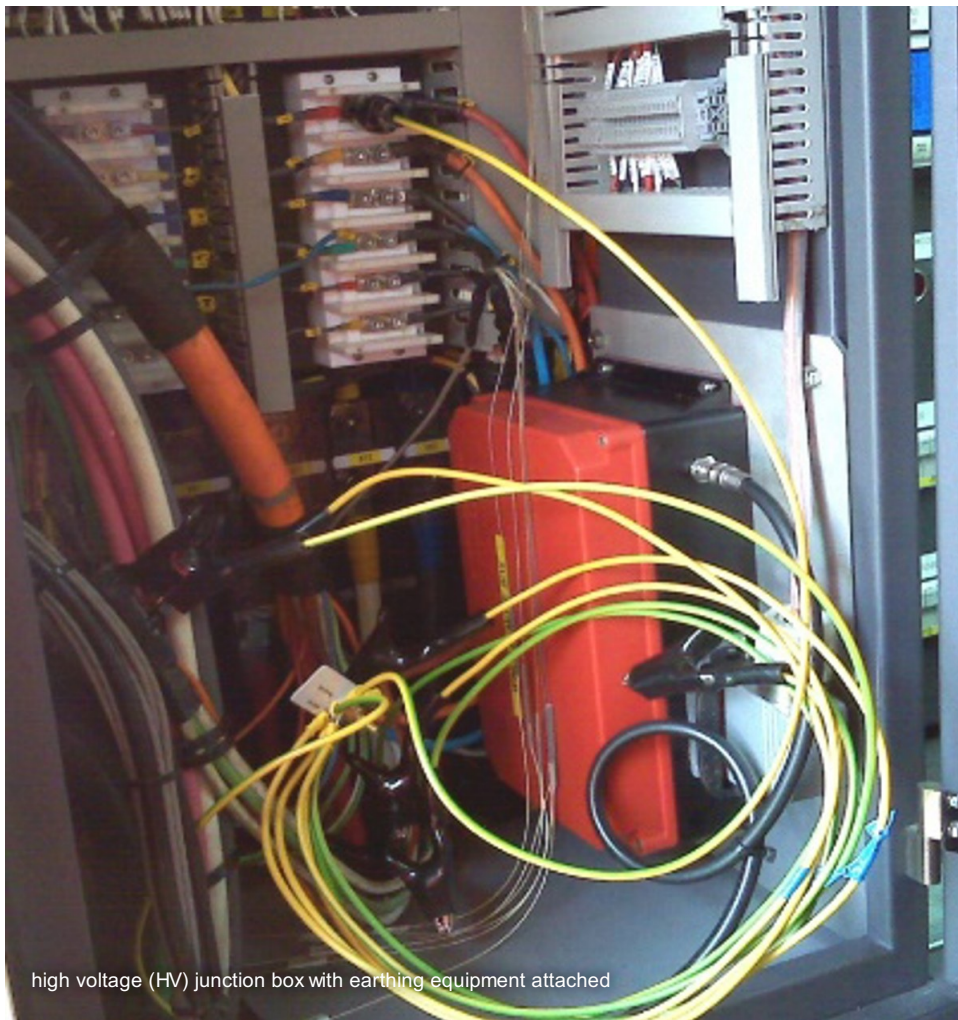
high voltage (HV) junction box with earthing equipment attached

- This conductor, whilst isolated from a direct power source, was identified as having an induced voltage present. The voltage was induced in the main lift umbilical on the deck winch.

- One of the functions of the earthing equipment was to tie conductors to earth and eliminate any induced voltage that may be present. On this occasion, two of the clips of the earthing equipment had become dislodged. The 'crocodile' clip arrangement was found not to be a secure method of attaching such a safety critical device.

- Some of the persons involved with this earthing equipment had not fully understood the criticality of the equipment, particularly in the case of high voltage (3000 V) and a long umbilical (3300 m). Nevertheless, this equipment was correctly used and all appropriate procedures were followed.

- Improve design of earthing equipment in such a way as to remove the possibility of inadvertent disconnection.
- Follow up with the manufacturer to include start up, induced voltage and isolation in training course material.
- Ensure all personnel working on work class ROV systems have completed HV training courses.
- Ensure signage is posted at all high voltage junction boxes warning of HV dangers and necessity to use appropriate earthing equipment.
