Lost time injury (LTI): Serious foot injury

Safety Flash Published on 9 May 2013 Generated on 17 January 2025 IMCA SF 07/13

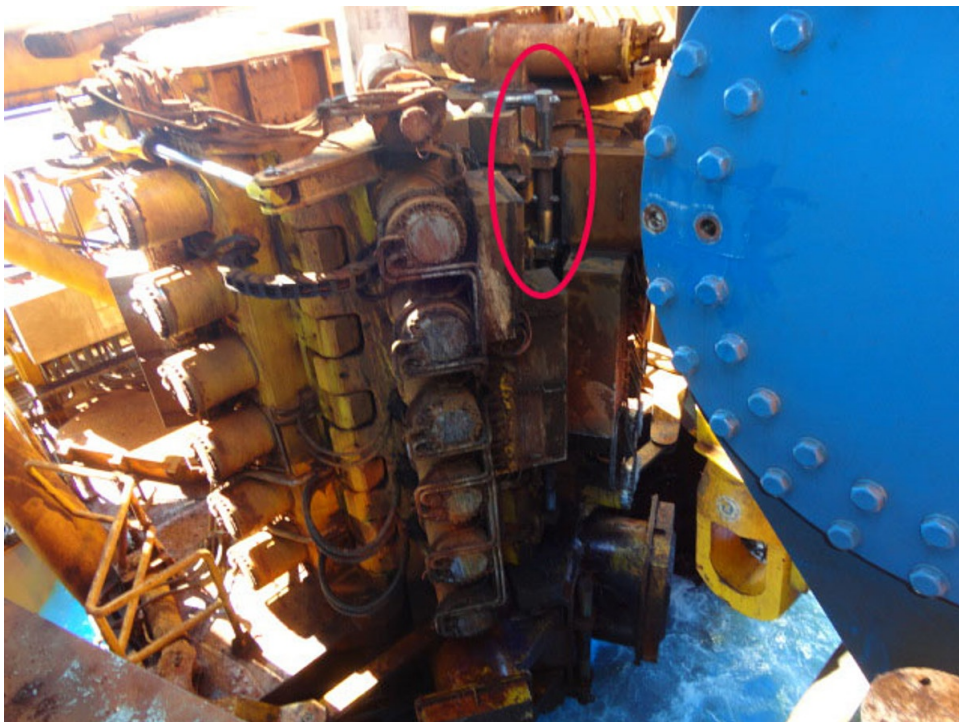
During J-lay pipeline operations, a malfunction was discovered in the locking pin designed to lock off the hang-off clamp (HOC). The pin would move down, but not up. Maintenance of the equipment was arranged. A crewman was assigned to clean the hang-off clamp using a water jet, and during this process he was supervised, from the deck level, by the Chief Engineer and 1st Engineer. When the cleaning was complete, he confirmed using hand signals to his supervisors that the job was complete.

The supervising team alerted the crewman that there would shortly be a test movement of the locking pin in order to test the functionality of the equipment. The supervising team alerted the crewman of the imminent movement of the pin, giving signals that he should move to a safer location. He confirmed visually that he had received this signal, but did not move, remaining with his foot on the pin. The 1st Engineer gave instructions via radio that the pin should be moved. Whilst moving, the pin squeezed the toe cap of the crewman's boot, causing injuries leading to partial amputation of his right big toe.

Hang-off clamp locking pin (circled)

- Improved job safety analysis to ensure adequate identification of all hazards and mitigation measures.
- Improved communication protocols and instituted use of common communications channel between crew and control room.

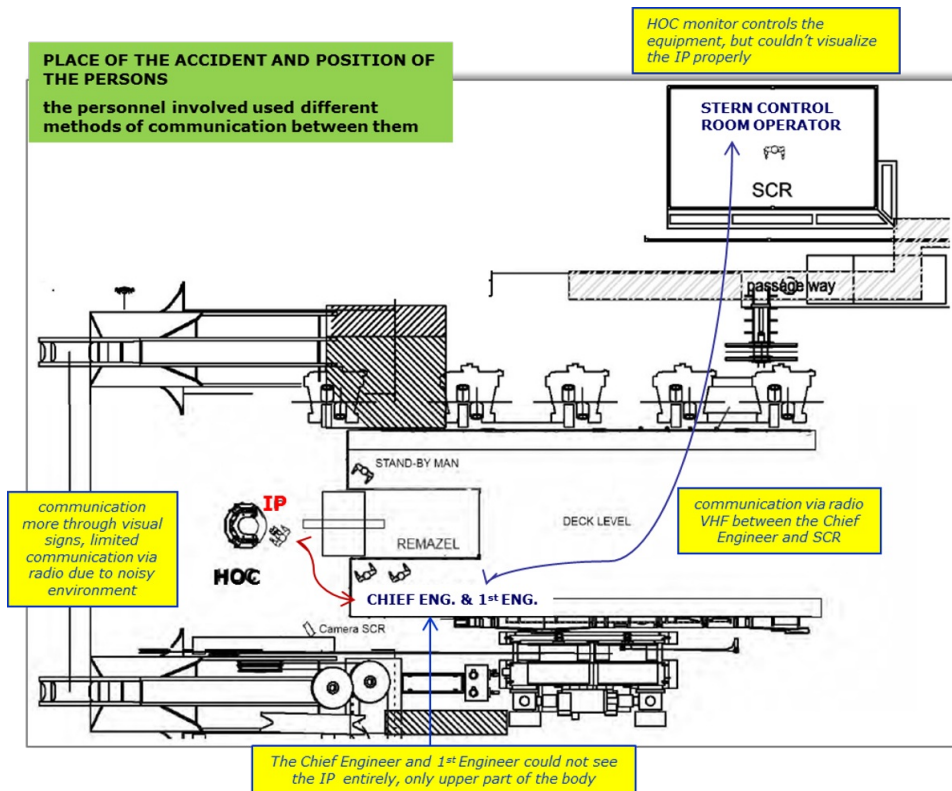
Line drawing showing place of incident and position of persons involved

- Improper communication between all persons involved:
 - Injured person and supervisory team communicated using hand and visual signals and there was no confirmation that the signals were understood as intended.
 - 1st engineer and control room operator communicated by radio.
 - There was no communication between injured person and control room operator.
- The control room operator could see the hang-off clamp, but could not see personnel working nearby.
- There was no evidence of any toolbox talk before the operation to agree on proper communication channels or planning of the operation.
- Whilst a job safety analysis and permit to work had been issued, these did not fully identify the task hazards.
