Near-miss: Failure of gas quad fitting

Safety Flash Published on 9 May 2013 Generated on 16 January 2025 IMCA SF 07/13

A member has reported an incident in which there was a potentially catastrophic failure of a high pressure fitting on a gas quad.

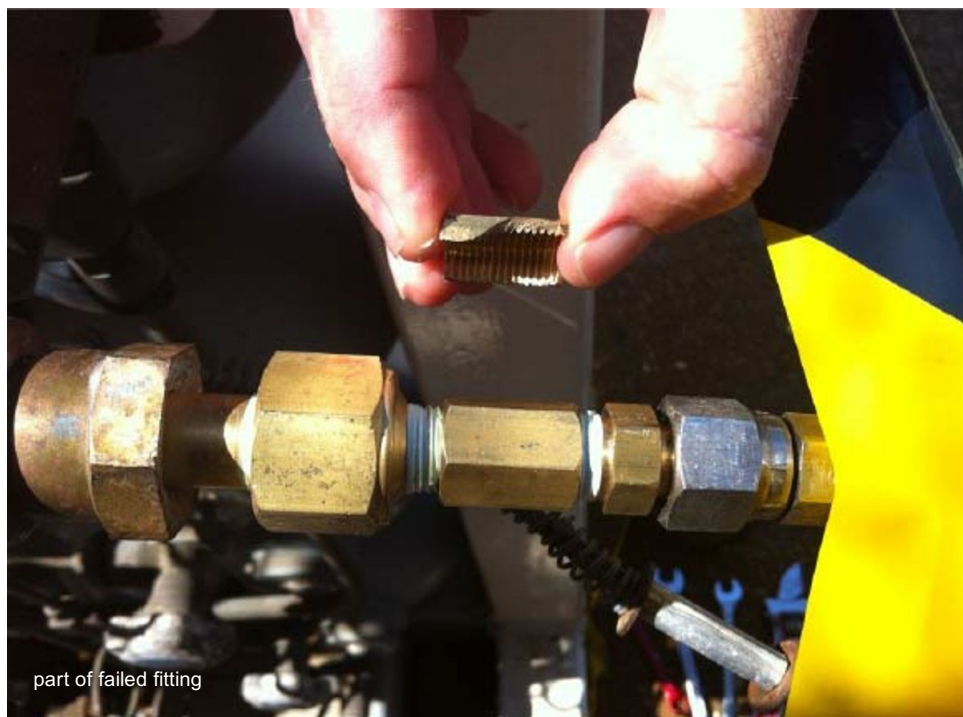
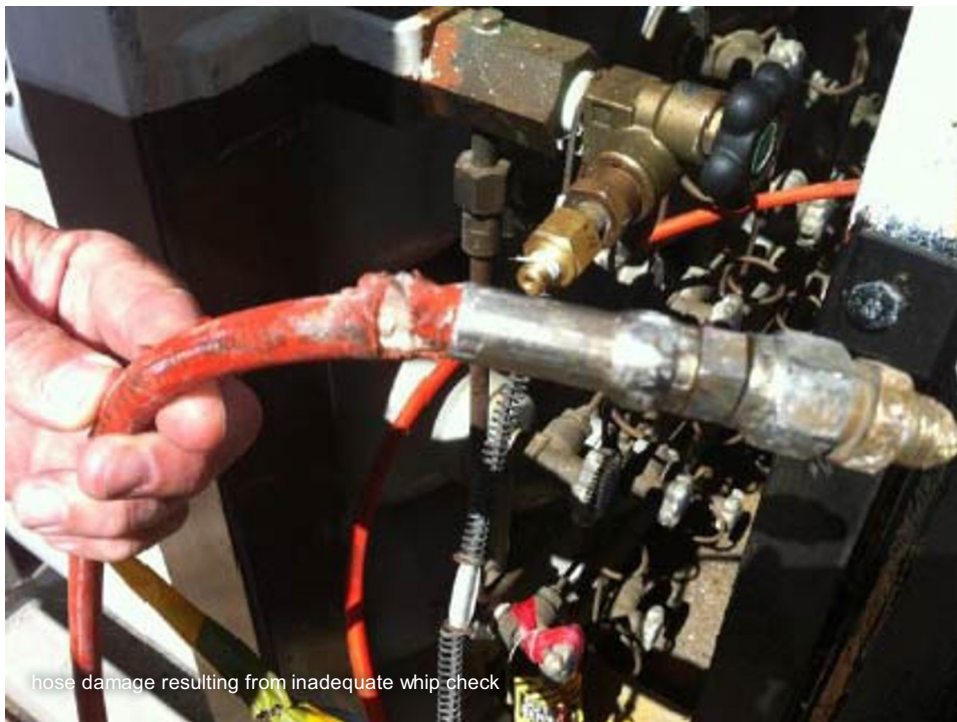
The incident occurred in a yard ashore when crew were carrying out pre-mobilisation equalisation transfer between banks on mixed gas DIV64 quad pack using high pressure (HP) hose. The wrong fitting (incorrect thread and low pressure (LP) rather than HP) was used to connect the HP whip to the king valve on the quad. The fitting failed due to a hairline crack as the gas transfer was being conducted between the HP banks.

The LP fitting failed such that it split into two pieces. One piece was found in the immediate vicinity; the other was found 20m away from the point of failure. It was later discovered that this piece had travelled with such force that it had hit and chipped an internal brick wall within a nearby workshop. The trajectory of this second piece would have crossed the main general workshop area in the facility at a height of approximately 3 metres where an estimated 10 other persons had been working. There were no injuries.

- In order to complete this task in equalising gas between the mixed gas DIV64 internal banks, use was made of NPTT (tapered) adapter fittings from both the HP king valve stem connection ports and adapting to the HP transfer hose, and in this incident both the thread type and the choice of material were incorrect. Low pressure fittings were used rather than high pressure fittings.

- Whip checks had been installed at each end of the transfer hose and secured to the DIV64 frame prior to equalisation operations being conducted. However, the hose end at the point of failure did not adequately choke or restrict the hose to a point where by it should have prevented the uncontrolled movement. This resulted in the hose also being damaged and ripped at the section where the stainless steel hose crimp is machine fitted (see photo).

- An identical ¼" NPTP brass socket fitting arrangement had been used on the other end of the hose; upon inspection, a hair-line crack was found in the material.

- Additionally the first section of the brass fitting had clear visual evidence of heavy condensation, and icing on the exterior of the other associated adapter fittings at the point of the pressure drop which would have further contributed to reducing the structural integrity of material under high pressure.

- Pressure of circuit was above the coupler's capacity.
- Crimped swivel fittings not suited to pressure of this level.
- Crew were not aware of different thread types.
- Whip checks insufficient.
- Valves open more than they needed to be.
- Regulator not used.
- Pressure not monitored.
- Over-tightening on coupler resulted in hairline stress cracks.

- Equipment should be of sufficient pressure rating.
- Improved training and information were required on this task.
- Risk assessment for this task needed to be more detailed.
- Hose securing – whip checks – should be improved.
- Consider increasing size of restricted access area during high pressure work.
- Real-time measurement of high pressure should be in place.
- Time allowed for this work should be realistic.
- Complacency is to be guarded against.
