Vessel activities near platforms – two incidents

Safety Flash Published on 28 March 2017 Generated on 28 January 2026 IMCA SF 07/17

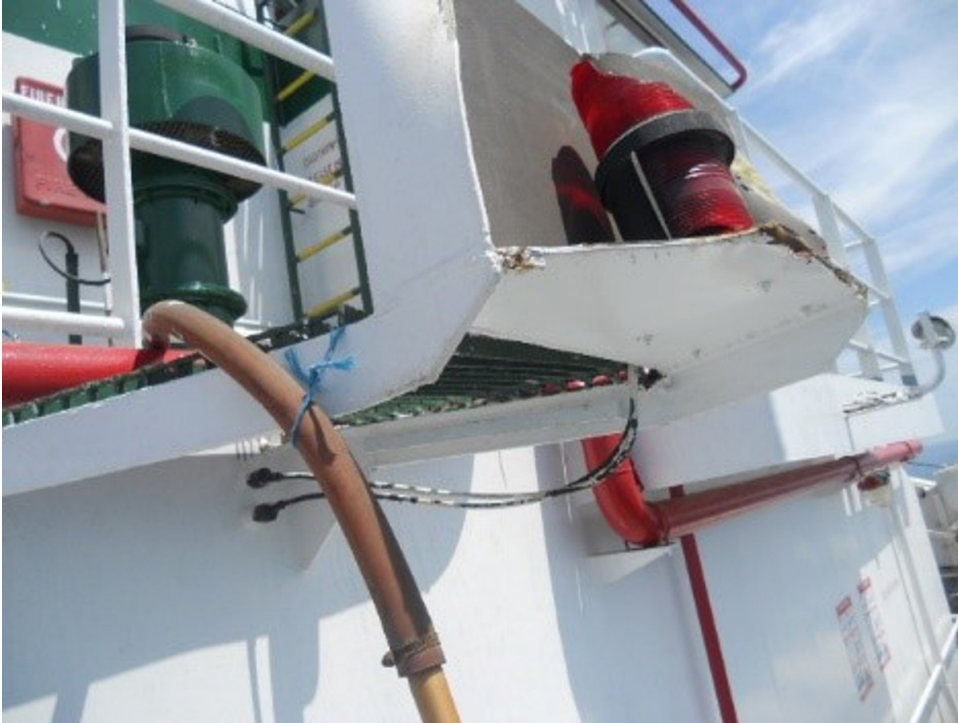
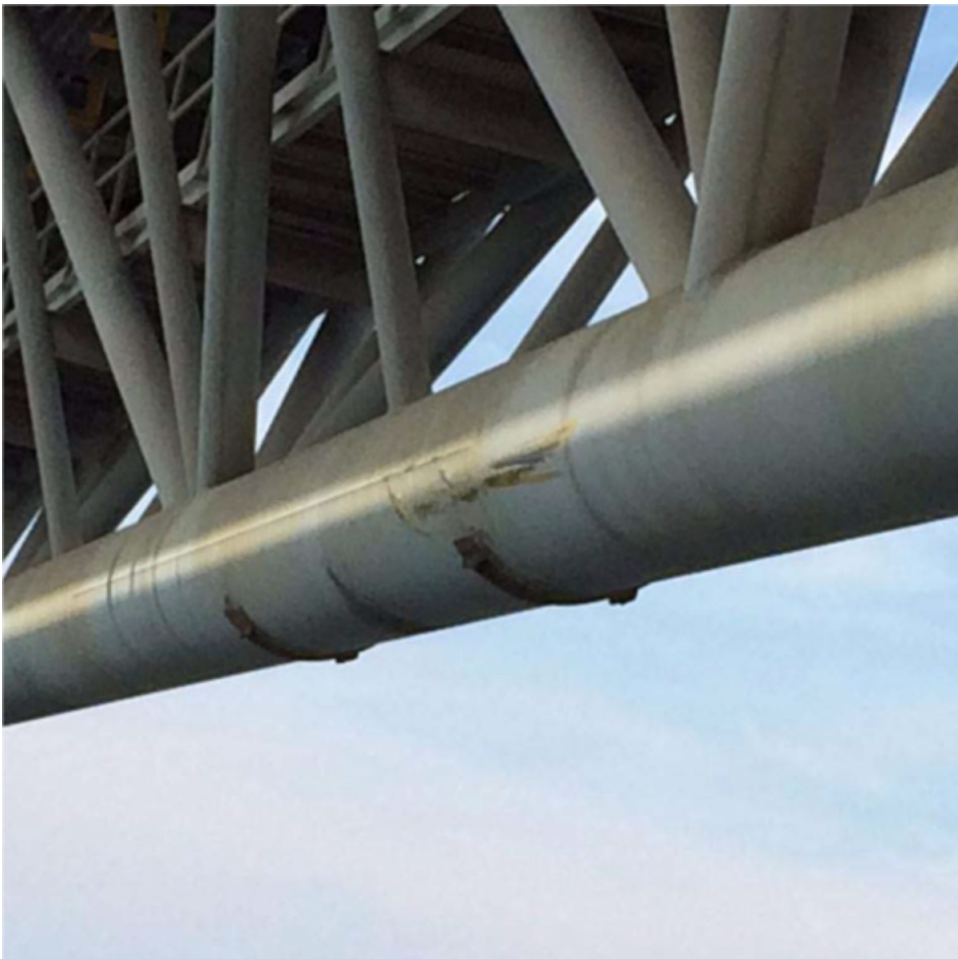
During personnel transfer operations with another vessel, one vessel came into contact with a fixed platform. The port side rudder failed causing the vessel to drift towards the platform flare bridge, making contact and causing slight damage to the flare bridge and the vessel’s navigation lights.

- Control of the vessel was lost, due to failure of a pin in the port side rudder angle feedback unit.
- Sea currents caused the vessel to drift into and collide with the bottom side of the flare bridge, causing minor damage.

An important lesson on both cases is the importance of extra vigilance and appropriate care when undertaking operations in the 500-metre safety zone. Additionally, the following should be noted:

- Greater understanding and ownership of marine risk from an installation perspective.
- Strict operating discipline in compliance with established procedures and recognised operating limits.
- Better quality communications between installation and vessels.
