## Near miss: Cargo shifted on deck in heavy weather

Safety Flash Published on 18 April 2019 Generated on 23 January 2025 IMCA SF 07/19

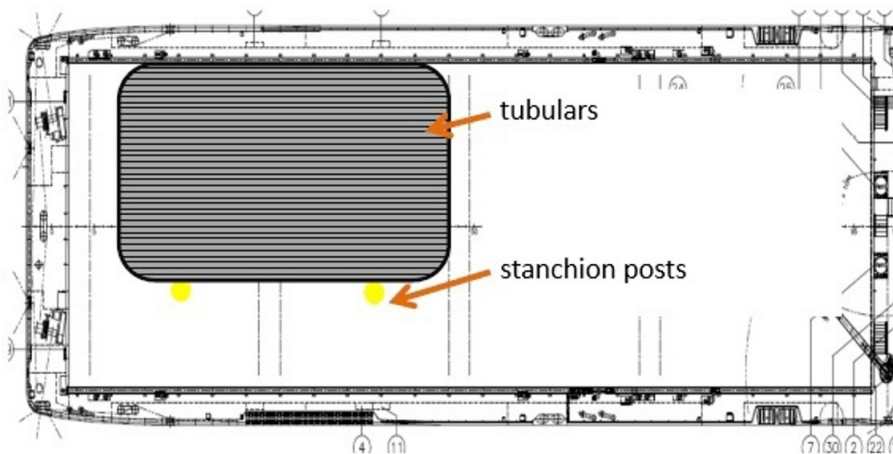
Both stanchion pins sheared at the base/weld (see images below).

It is believed this incident happened because there was a small gap of 10-15 cm between the forward pin and the casing, which allowed additional load on the after pin when the vessel was rolling, thus causing the aft pin to shear.

The most recent visual inspections of the pins were within the last three months and were found to be in a satisfactory condition. However, it was later identified that the pins were several years old and had been in use frequently during adverse weather/winter conditions.

- Incorrect securing method.
- Poor back-load planning (space between tubular and stanchion pin allowed movement).
- The welds on stanchion pins failed.
- Weather and sea conditions.

- Box in loads with heavier back-load (this would have occurred on this vessel, however, in this case operations were suspended by the crane operator on the installation, due to excessive wind speed).
- Re-assessment of life-span of securing pins. All pins were replaced with new and welds were subject to non-destructive examination (NDE);

During loading/back-loading of casing, risk assessment regarding possible additional stanchion pins was needed, especially during winter periods.
