Uncontrolled release of walk to work gangway

Safety Flash Published on 18 April 2019 Generated on 28 January 2026 IMCA SF 07/19

A walk-to-work (W2W) gangway system broke loose from its connection point.

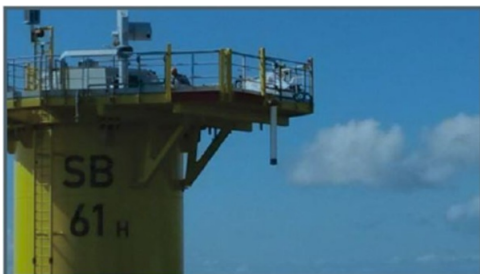
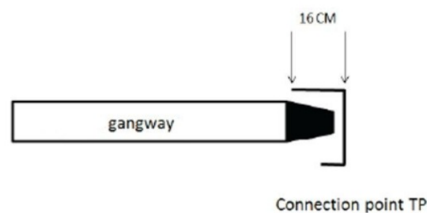
Connection point on TP (painted red)

- The gangway system was tested before the incident and it was observed that the system seemed to be reacting slower than normal, but as it performed well under tests earlier that day it was agreed between operator and captain to start operations.
- There were slight differences in the push-on point design on this installation (a substation) than on the turbine towers (see illustration).
- The weather and sea state at the time was within the working limits for the gangway system (actual 1.5 m and 15 knots versus design 3m Hs & 30 knots wind).

- AMC performance to be verified during annual inspection.
- Before connecting the gangway, position the gangway approximately 1 m from connection point, visually verify that AMC is stable and that the control error is within reasonable limits.
- Verify that the connection point is designed to fit the gangway with respect to shape and load.
