Vessel hull damage due to quayside contact

Safety Flash Published on 4 March 2021 Generated on 28 January 2026 IMCA SF 07/21

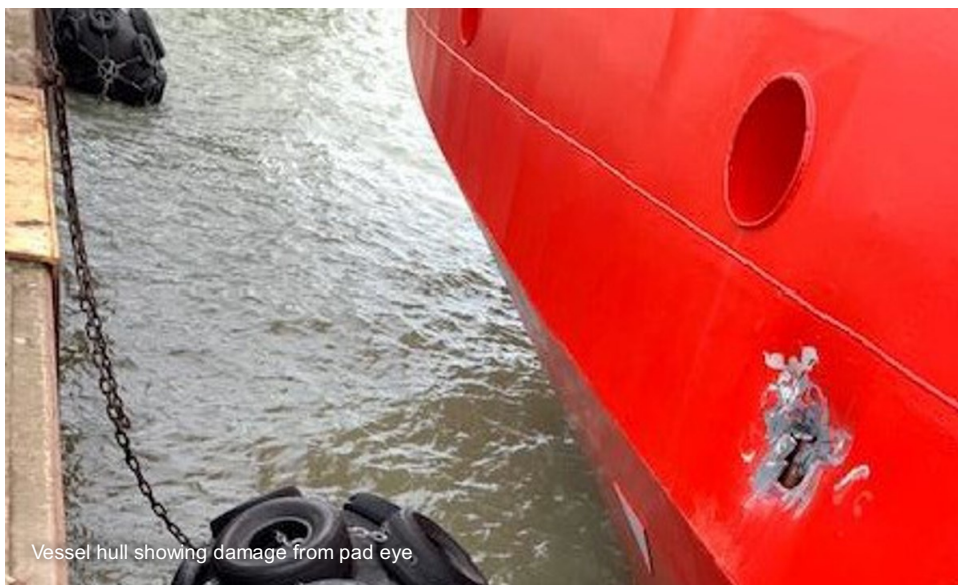
In one incident, a pad eye on the quayside edge made contact and penetrated the vessel hull plating.

At the time of the incident, the vessel was experiencing strong beam winds gusting up to 47 knots, pushing the vessel onto the quayside. Contact with the furthest forward fendering squeezed it out of position and underneath the quay structure. This allowed the forward section of the hull to come into contact with the protruding pad eye. It has become apparent that the fender resting place on the quay structure must have been previously damaged, enabling the fender to slide around the quayside supporting column.

Vessel hull showing damage from pad eye

In the first incident, the securing arrangements (pad eye) for the Yokohama fender must have been damaged at some point, but this was not reported to the vessel. This resulted in the Yokohama fender being able to move away from the jetty column and thus offering no protection to the vessel's hull.

- Wherever possible obtain a berthing plan in good time so as to make a full appraisal of fendering, mooring and gangway arrangements and request any necessary changes or clarifications.

- Ensure a pre-arrival toolbox talk is conducted so that all personnel involved in the berthing operation are aware of both shore-side and onboard mooring and fendering arrangements.
- Remain aware of the weather conditions when approaching the berth and if not satisfied with the situation, abort the approach and/or request tug assistance if appropriate and available.
- If it becomes apparent that the intended berth is not suitable, abort the approach and inform the Pilot/Port Authority and request alternative arrangements.
- Once moored alongside, monitor weather conditions including tidal variations which may affect the vessel movement and potential contact with quayside fendering, obstructions or infrastructure.
- Keep this handy list near your passage plan folder to ensure that future port calls consider same information.

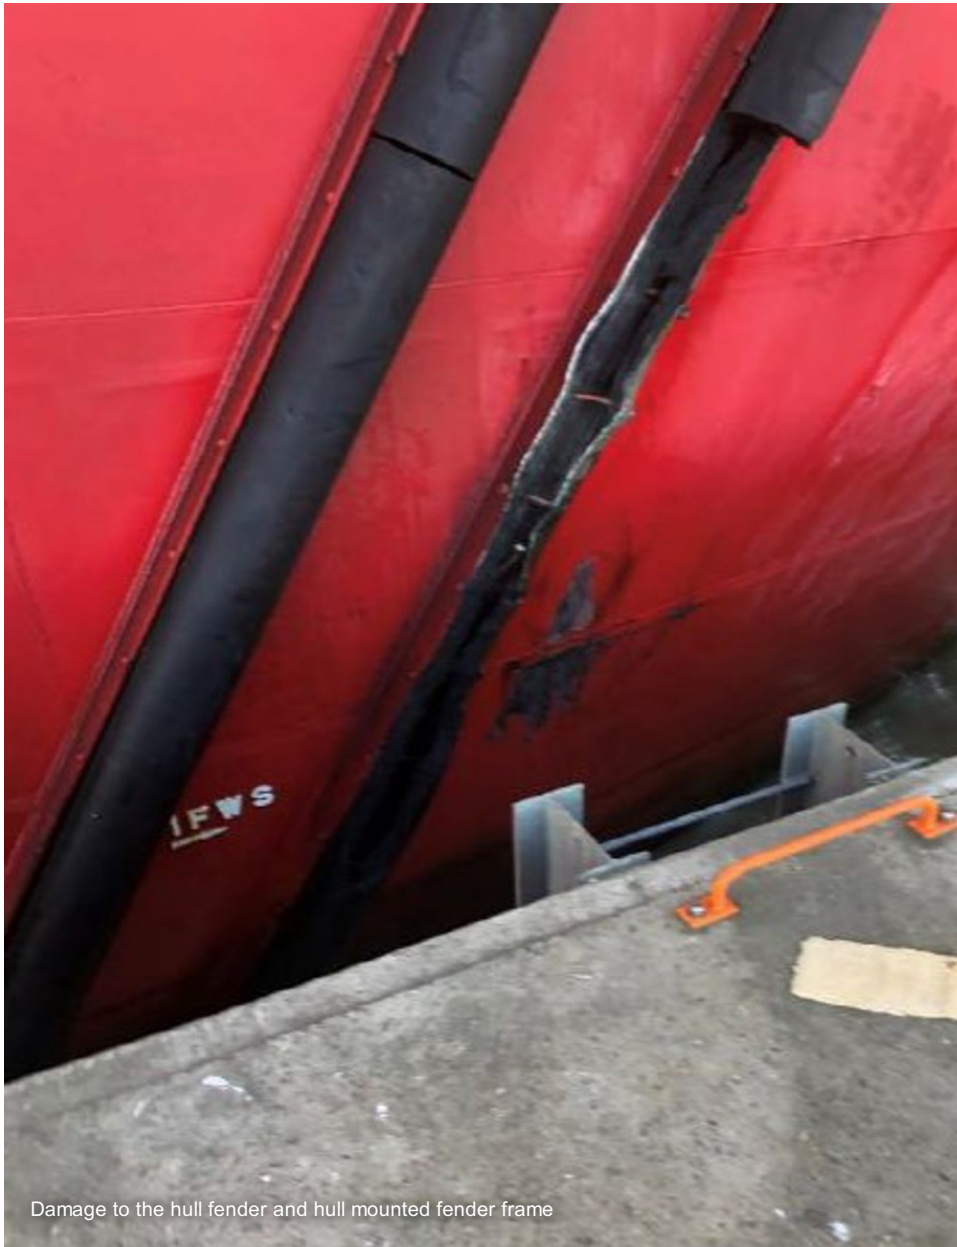
In the second incident, the vessel experienced damage to the hull fender and hull mounted fender frame.

This was caused because there were no Yokohama fenders as expected, but instead large steel plates with sheets of rubber for the facing. The quayside location was exposed to the weather; the vessel experienced a heave of up to 2 metres, resulting in the wear down of the ship fender rubbing against the top edge of the quayside fender plate.

In the second incident, the vessel Master was expecting Yokohama fenders. Instead the berth was fitted with metal, rubber faced plate fenders, which were not suitable for the hull layout of the vessel and resulted in damage to the vessel's hull plating and fixed fenders.

Damage to the hull fender and hull mounted fender frame
