Vessel hull damage due to quayside contact

Safety Flash Published on 4 March 2021 Generated on 23 January 2025 IMCA SF 07/21

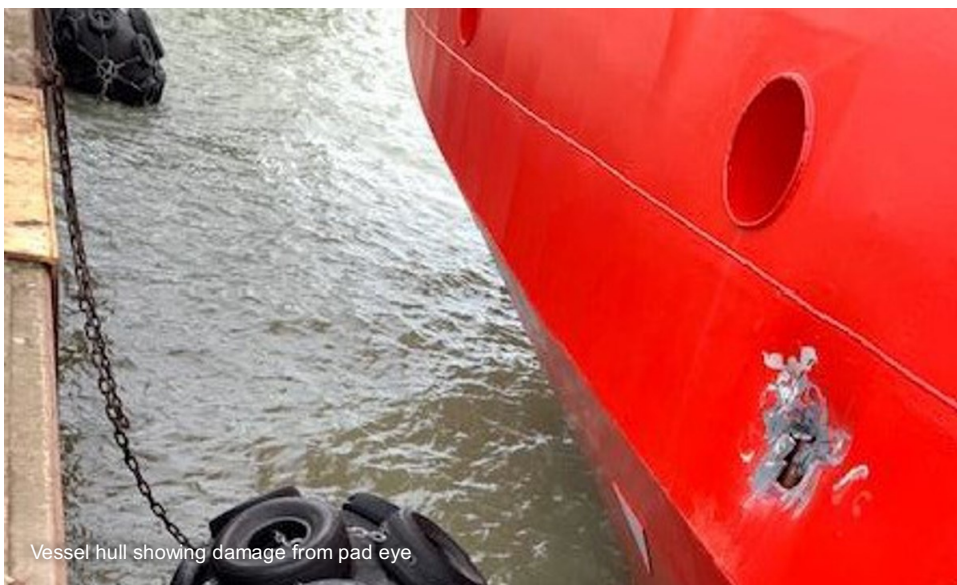
In one incident, a pad eye on the quayside edge made contact and penetrated the vessel hull plating.

At the time of the incident, the vessel was experiencing strong beam winds gusting up to 47 knots, pushing the vessel onto the quayside. Contact with the furthest forward fendering squeezed it out of position and underneath the quay structure. This allowed the forward section of the hull to come into contact with the protruding pad eye. It has become apparent that the fender resting place on the quay structure must have been previously damaged, enabling the fender to slide around the quayside supporting column.

Vessel hull showing damage from pad eye

In the first incident, the securing arrangements (pad eye) for the Yokohama fender must have been damaged at some point, but this was not reported to the vessel. This resulted in the Yokohama fender being able to move away from the jetty column and thus offering no protection to the vessel's hull.

- Wherever possible obtain a berthing plan in good time so as to make a full appraisal of fendering, mooring and gangway arrangements and request any necessary changes or clarifications.

- Ensure a pre-arrival toolbox talk is conducted so that all personnel involved in the berthing operation are aware of both shore-side and onboard mooring and fendering arrangements.
- Remain aware of the weather conditions when approaching the berth and if not satisfied with the situation, abort the approach and/or request tug assistance if appropriate and available.
- If it becomes apparent that the intended berth is not suitable, abort the approach and inform the Pilot/Port Authority and request alternative arrangements.
- Once moored alongside, monitor weather conditions including tidal variations which may affect the vessel movement and potential contact with quayside fendering, obstructions or infrastructure.
- Keep this handy list near your passage plan folder to ensure that future port calls consider same information.
