MAIB: Unexploded ordnance – subsea explosion causes injury and damage

Safety Flash Published on 22 March 2022 Generated on 28 January 2026 IMCA SF 07/22

The UK Marine Accident Investigation Branch (MAIB) has published its [Accident Report 1/2022](#) into a subsea explosion which damaged crab potting vessel *Galwad-Y-Mor* on 15 December 2020.

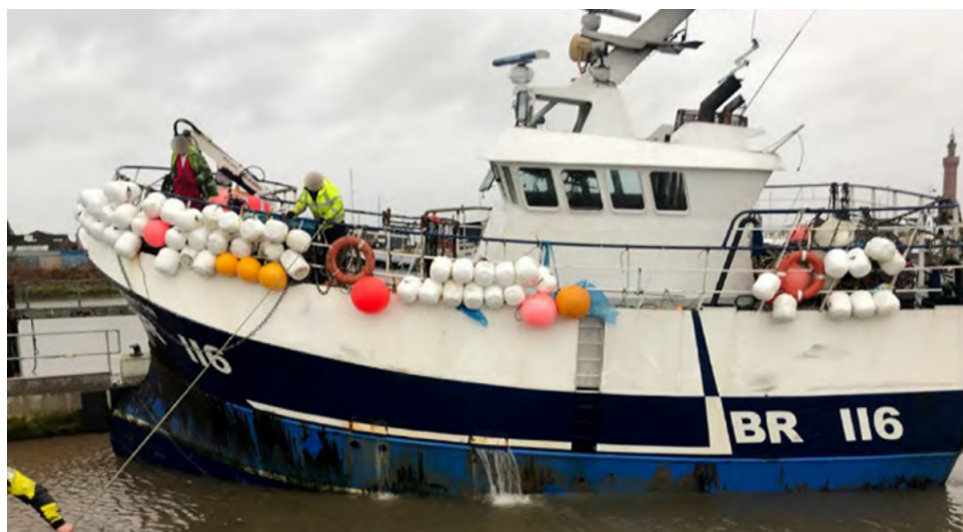
A 15m crab potting vessel was hauling pots in the North Sea approximately 22 miles north-east of Cromer. The crabbing gear disturbed a 250kg unexploded WWII bomb, which went off on the seabed 30m below the vessel. The ensuing explosion caused a shock wave that threw the boat about, resulting in significant injuries to five of the seven crew and major damage to the vessel's hull and machinery.

When the bomb went off, three loud bangs were heard by the crew on the main deck. The vessel was thrown about. Propulsion and electrical power immediately failed. The main deck was deluged with seawater and one crew member's personal flotation device (PFD) automatically inflated. The skipper had hit his head and was dazed; four of the crew were severely injured but all remained conscious. The wheelhouse equipment was seriously damaged, water flooded onto the main deck, and into the engine room, and the vessel settled low in the water. The skipper roused the night watchman and made a distress call with a handheld VHF radio on channel 16. Unsure that the distress call had been received, he texted the skipper of another fishing vessel and requested that a distress message be relayed to the coastguard. *Galwad-Y-Mor's* skipper launched the life raft with the help of a crew member and ordered the crew to prepare to abandon ship.
