Lift bag near miss

Safety Flash Published on 13 March 2023 Generated on 22 January 2025 IMCA SF 07/23

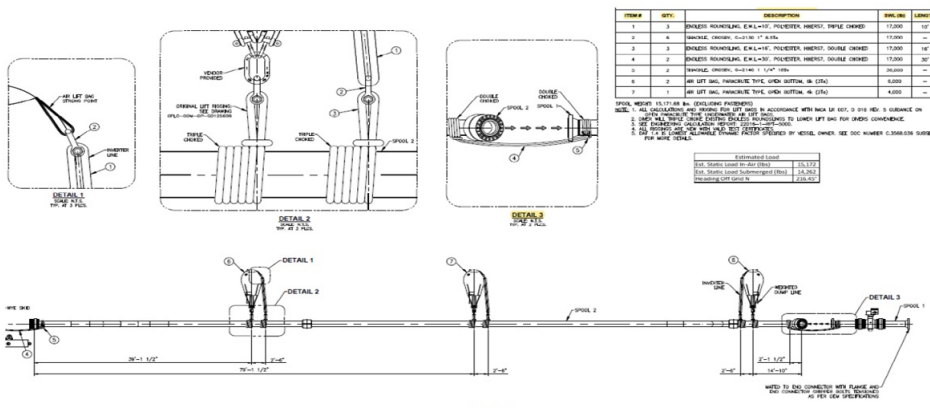
Spools were being rigged subsea to gain the third wrap needed for the lift bag attachment

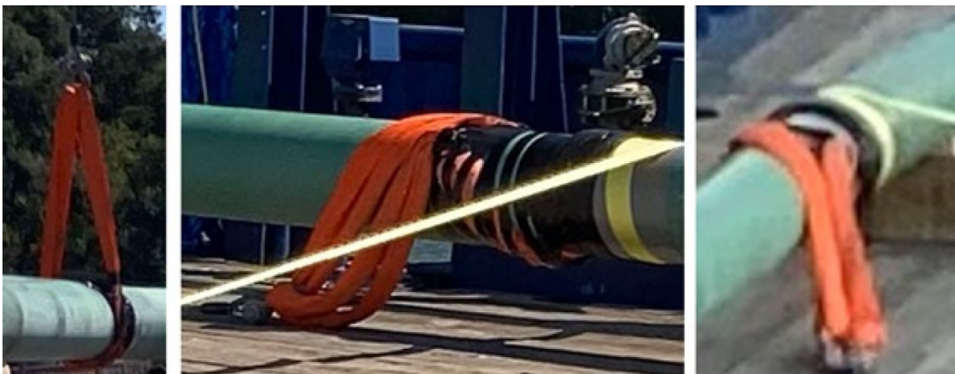
Black duct tape added to “hold” the rigging in place

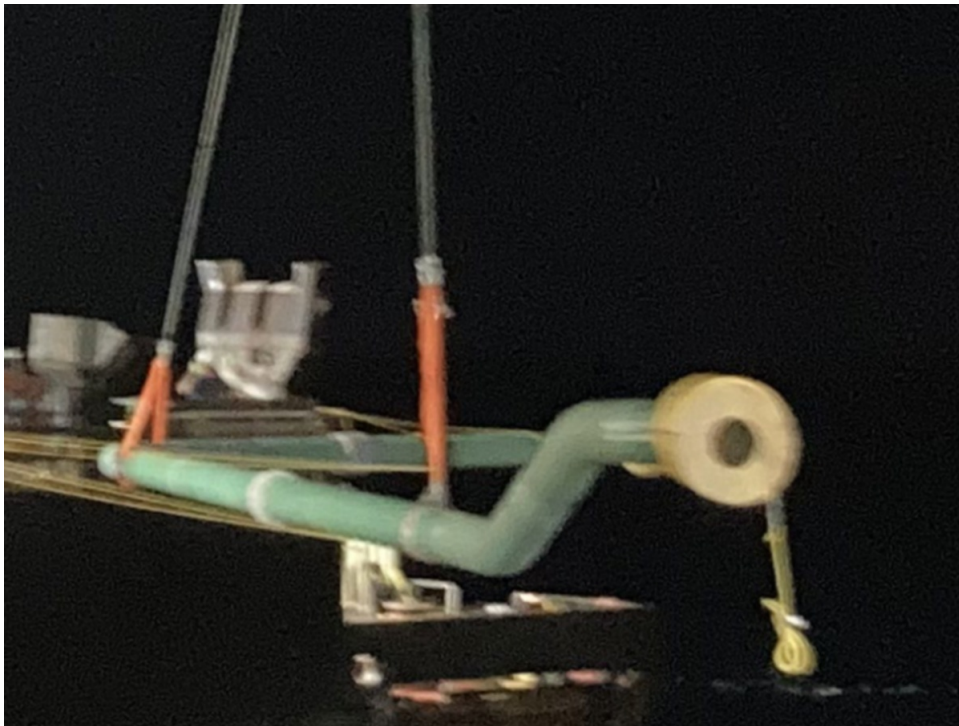
- The rigging had been changed earlier but this change had not been communicated to the dive team.
- As the final spool was lowered, late at night, rigging changes were not noticed.

Note the middle leg is not choked, as per the drawing, change not noticed, nor articulated to the divers

- Ensure one single person is accountable for rigging, reporting to the Superintendent and collaborating with the dive team.
- Improve management and installation of rigging configurations.
