Dangerous transformers

Safety Flash Published on 2 December 2000 Generated on 17 January 2025 IMCA SF 08/00

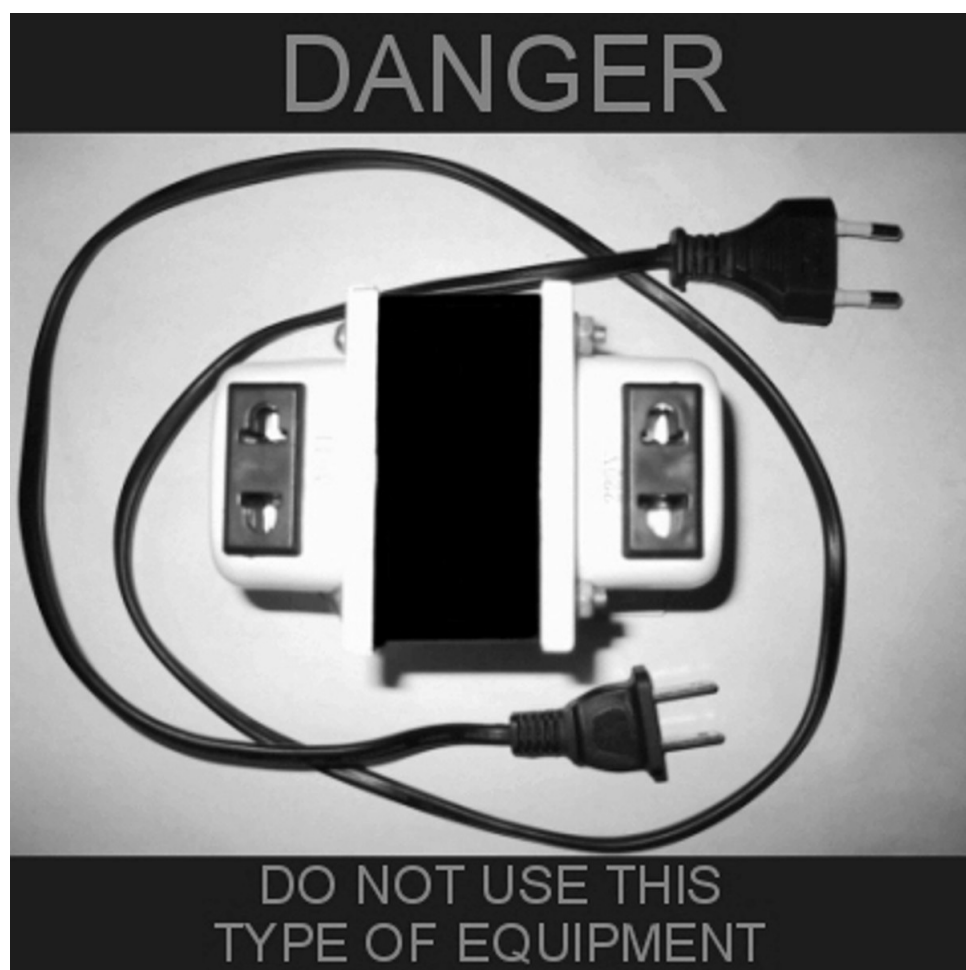
Below is a picture of one of the transformers.

- The transformers have no earth and thus do not comply with relevant class (class I equipment – earthed) for appliances of this kind.
- The transformers are not double insulated and in fact have a metal casing. This does not comply with the relevant class (class II equipment – double insulated) for appliances of this kind.
- The lead has two plugs and the transformer two sockets. It is possible to plug a 220v supply into the 110v socket and produce 440v.
- If power is fed to the transformer then both sockets become live and there is a high risk of somebody being electrocuted.
