## Lifeboat davit sheave incident

Safety Flash Published on 3 July 2003 Generated on 21 January 2025 IMCA SF 08/03

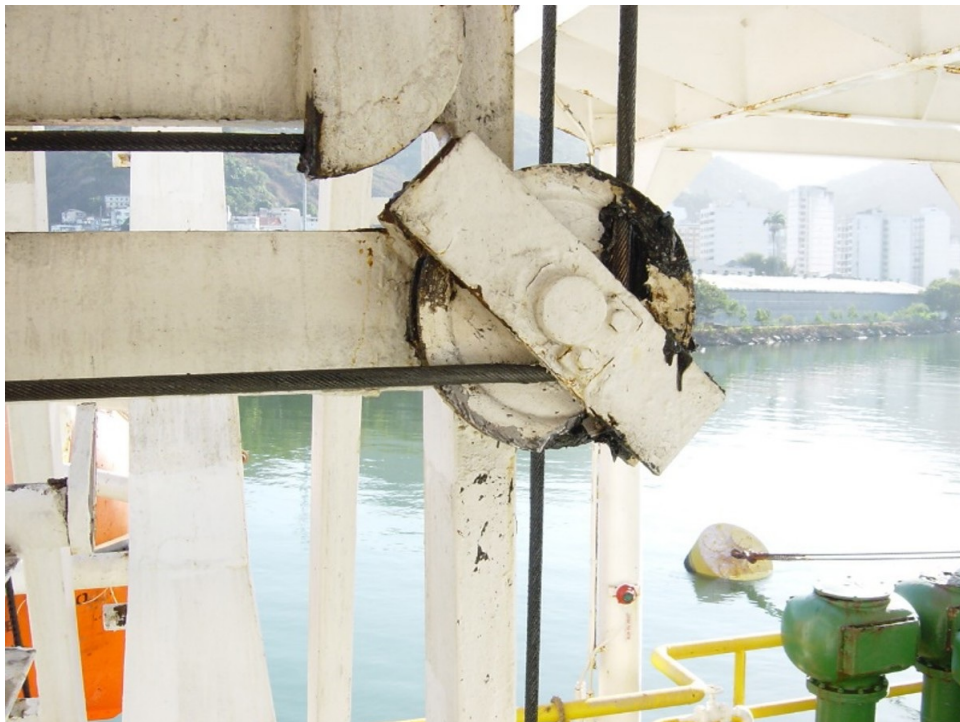
Close inspection revealed that one of the davit sheaves had disintegrated around its perimeter (circumference) and that this, in turn, had caused the falls wire to jump clear of the sheave and become trapped between the sheave face and sheave bracket on the davit structure (see figure).
