Serious injury during pipestalk rolling operation

Safety Flash Published on 22 June 2006 Generated on 17 January 2025 IMCA SF 08/06

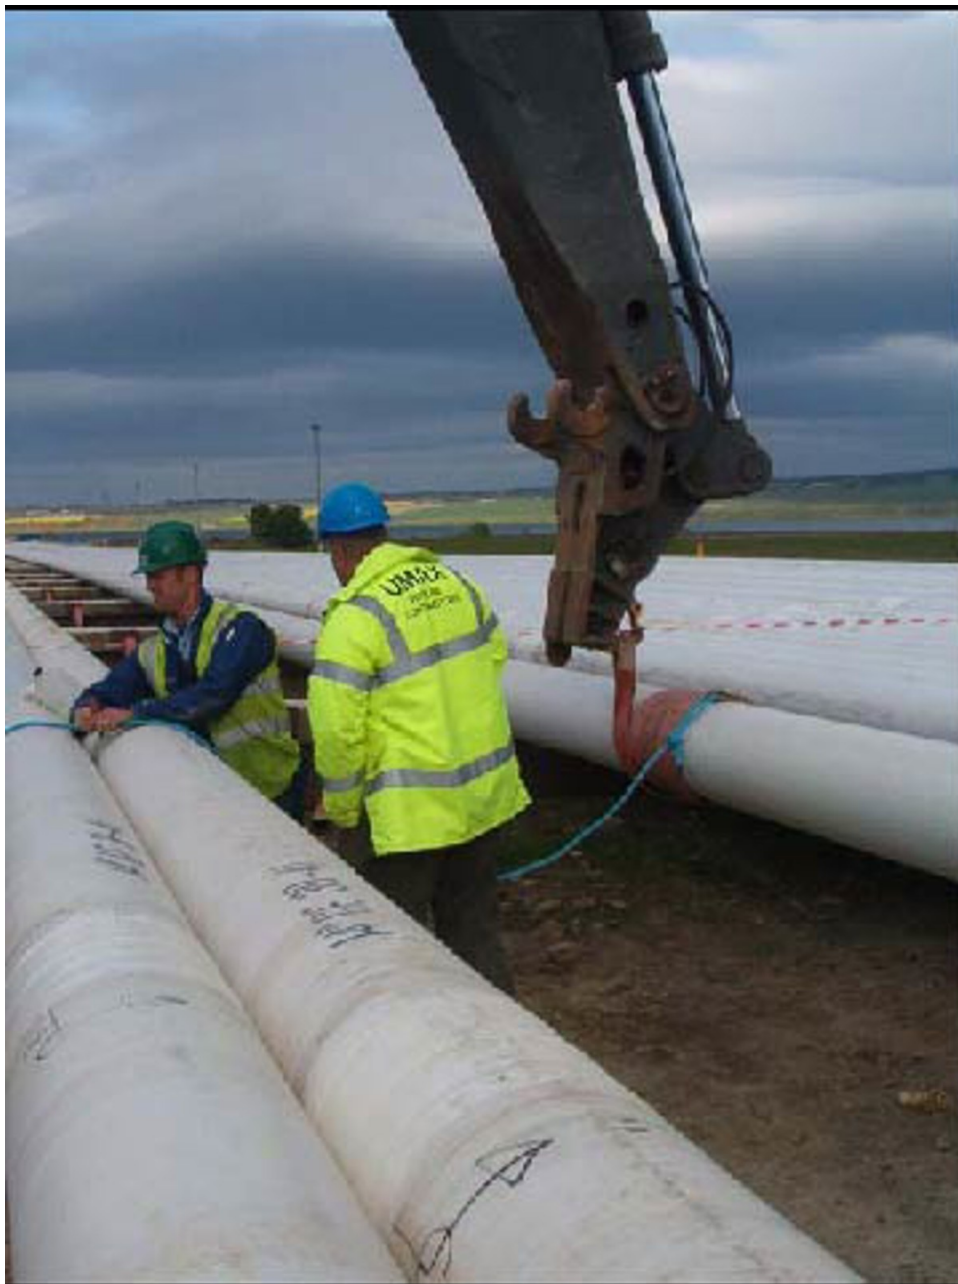
The injured person was assisting with planned pipe stalk rolling operations when he became entangled in a tag-line that subsequently trapped and held him against the rolling pipe stalk. He was carried over the top of the rolling pipe stalk and crushed between that pipe stalk and the one adjacent to it.

As a result, he sustained fractures to both legs and serious internal injuries. First aid was administered on site and he was immediately transported to hospital.

- Although only a minimal amount of lifting at the mid point of the pipe stalk was involved, this activity had not been recognised as a lifting operation and, therefore, the appropriate level of control and supervision had not been applied.
- There was evidence that, while a safety management system was in place, the procedures and risk assessments used to control the work had not been adequate.
- The task was being carried out by competent, experienced personnel, who had completed the task without harm many times before. Nevertheless, there was evidence that the personnel involved were unaware of the risk assessments and procedures in place and worked to custom and practice, rather than to procedures.

- Tag-lines are useful, often essential, attachments to assist in controlling a load. However, all personnel should be acutely aware of the potential risk of snagging or entanglement of themselves or other equipment when using tag-lines and ensure that they position themselves safely away from the load.
- The same level of compliance with procedures; and awareness and control of risk should be applied to 'routine' work as to higher risk, and non 'routine' activities, particularly where lifting operations, however 'routine' or low-level, are involved.
