Partial parting of a bell main lift wire

Safety Flash Published on 24 April 2008 Generated on 14 January 2025 IMCA SF 08/08

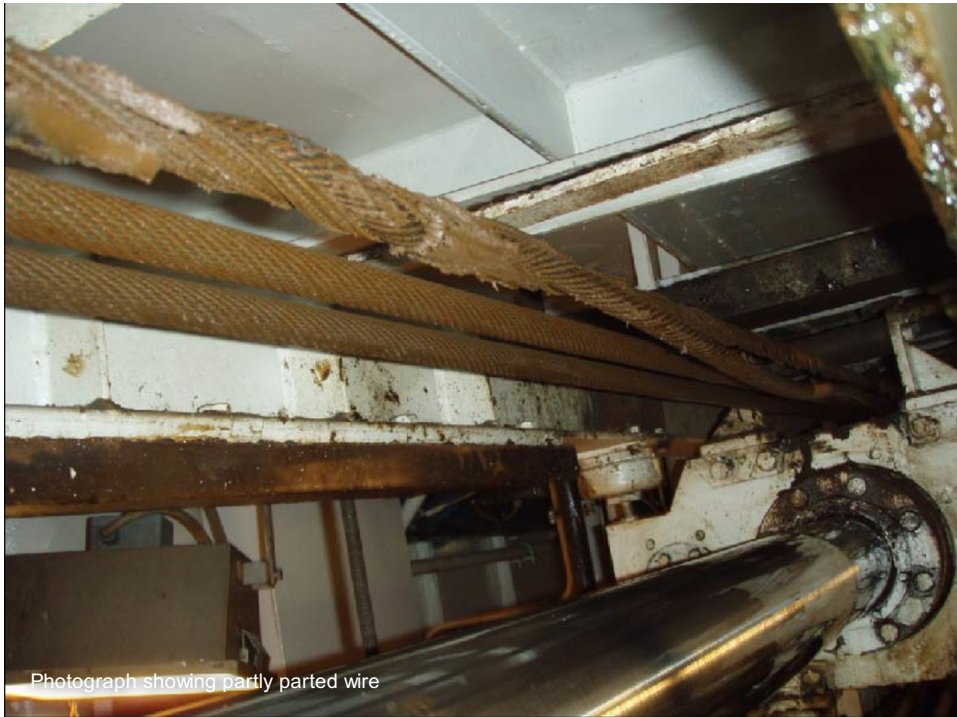
During bell recovery a member of the dive team noticed damage on the bell main lift wire, 48m from the bell.

Photograph showing partly parted wire

- The cause of the wire rope failure was internal corrosion damage where the inner core wires of the rope had been reduced in size by up to 50% with no external damage visible.
- The rope lubricant had been lost internally and the galvanised coating was no longer present. Both of these two factors had accelerated the corrosion of the wires.
- The local corrosion of the core wires had led to a loss in diameter and

strength. The loss in strength had resulted in overload of the individual wires and placed additional stress on the core.

When checking the size of the bell wire (nominally 22mm diameter) approximately 3m each side of the damaged area, the diameter was recorded as 21mm. At various other areas of the wire the readings were between 21.3mm and 21.8mm.

ISO 4309 2004 paragraph 3.5.7 allows for a 3% reduction for multi strand wire making 21mm outside acceptable tolerances.

Members are urged to consider all of the points raised and review their own wire

rope maintenance and testing policies as appropriate.

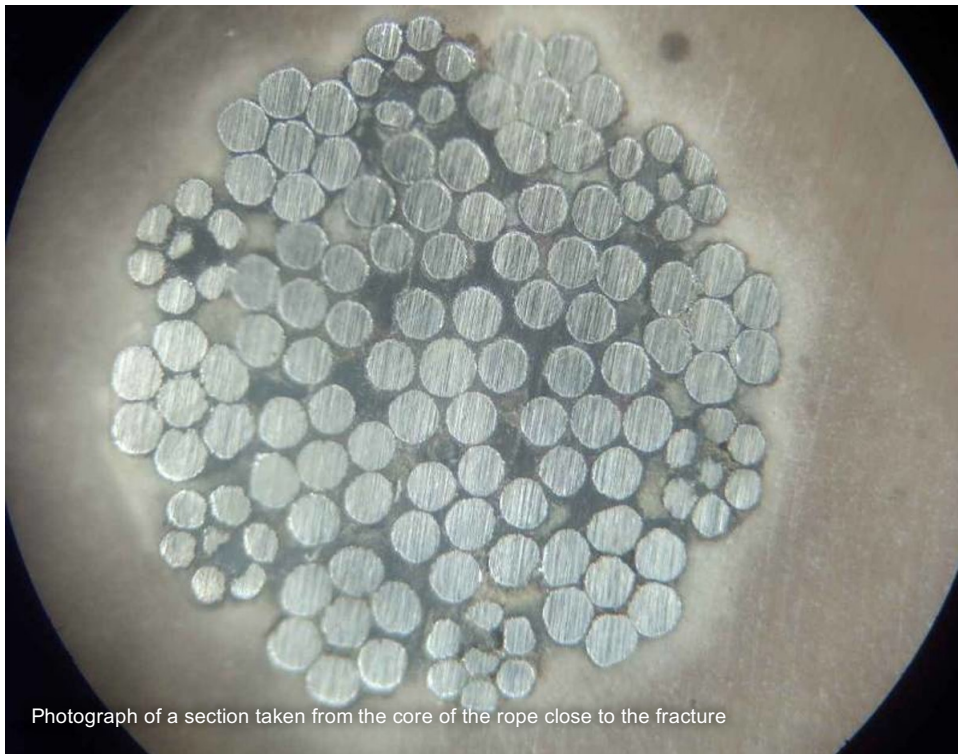
Photograph of a section taken from the core of the rope close to the fracture

- The extent of the detrimental effect of multiple sheaves and sheave diameters in use.
- The wire rope had, over a number of years, been bent over heave compensator sheaves which could have led to internal fretting taking place within the rope once the rope lubricant had been lost.
- High peak loads could have been experienced on the system when the heave compensators were fully compressed before the bell and cursor were handled in moon-pool.
- The bell wire was eight years old which was inside the company's discard policy of ten years which may need to be re-assessed.
