Serious finger injury: Procedures during engine maintenance

Safety Flash Published on 12 April 2017 Generated on 28 January 2026 IMCA SF 08/17

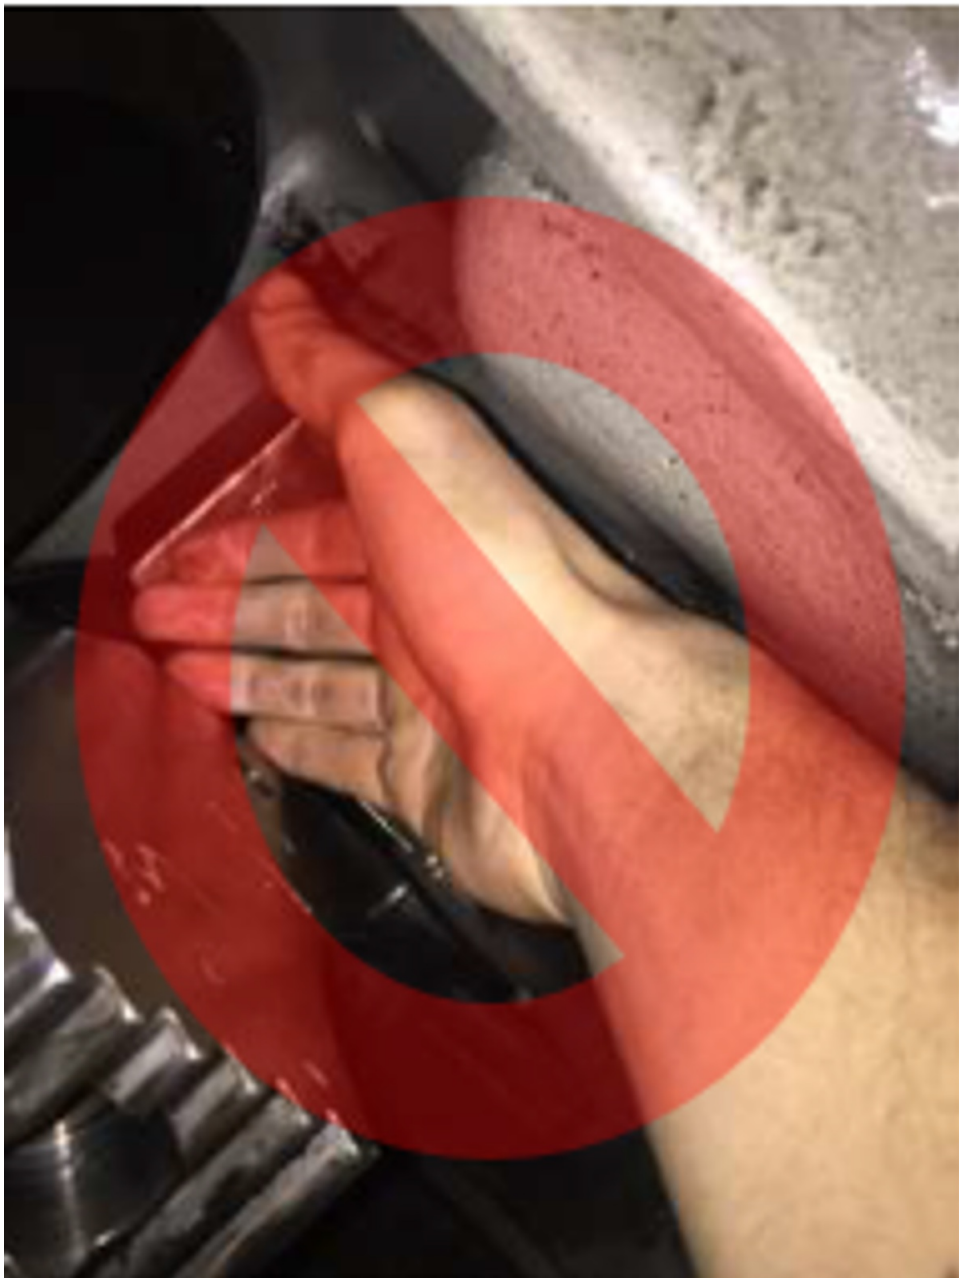
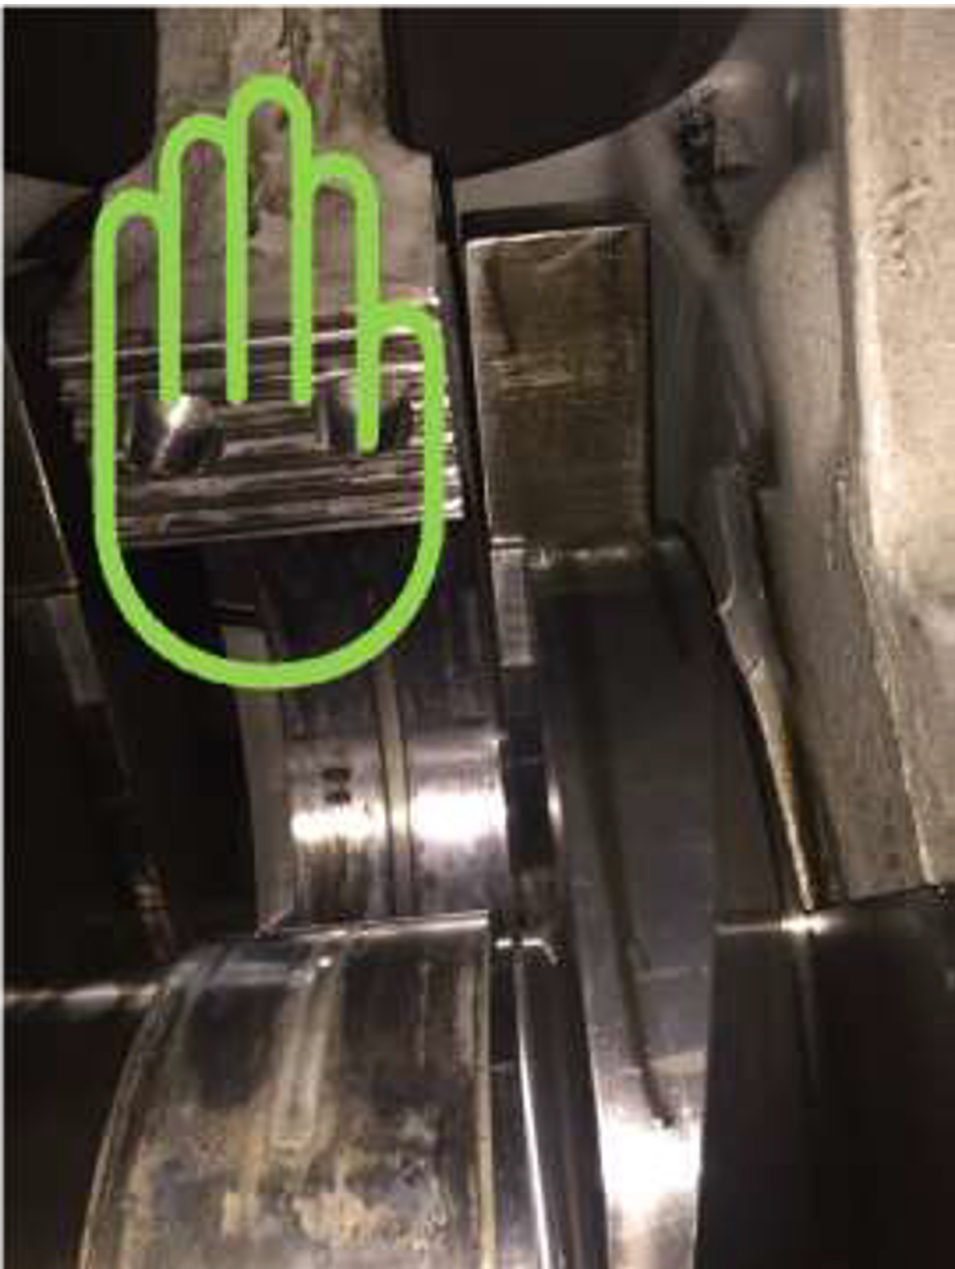
The crank web counter balance was not seen by the IP as it came around and trapped his little finger between the con rod and crank web counter balance.

- **Work Planning** – the work was fully planned, with Risk Assessment and Toolbox Talks conducted, recorded and on-file.
- **PPE** – the IP was wearing full required PPE including mechanics gloves; use of these gloves prevented the injury being far worse.
- **Immediate Actions** – on-board immediate first aid was applied and subsequent external medical treatment was sought.
- **Follow-up Actions** – the vessel is updating the existing risk assessment to improve safety emphasis on correct hand placement during the task;
- **Hand Placement** – the IP had his hand in an unsafe location within the machinery, between the con rod and counter balance; his hand should have been on the con rod itself, with thumb tucked in, to avoid pinch/trapping risks as the counter-balance moved.

- **Question:** *Was a soft stop used around the con rod, to lift it off the shaft?*
 - **Answer:** Not at the time but, since the incident, we have carefully considered different options for supporting the piston and connecting rod whilst turning the crankshaft out, whilst also protecting these components from damage; it is possible to use a substantial wooden lever or a soft stop to avoid placing hands inside.
