## Mooring near miss: Guide roller pin suffered material failure

Safety Flash Published on 1 April 2022 Generated on 25 April 2025 IMCA SF 08/22

A deck stand guide roller pin suffered material failure.

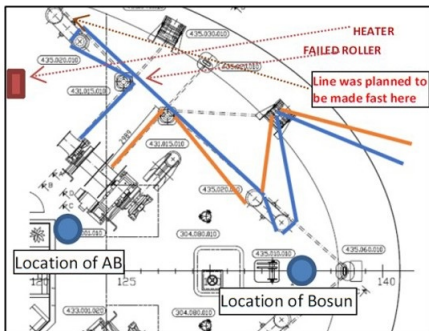
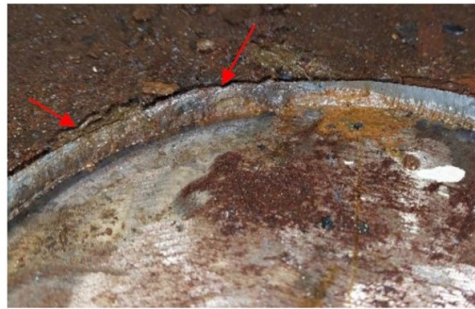
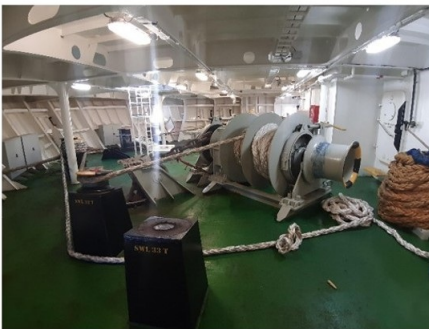
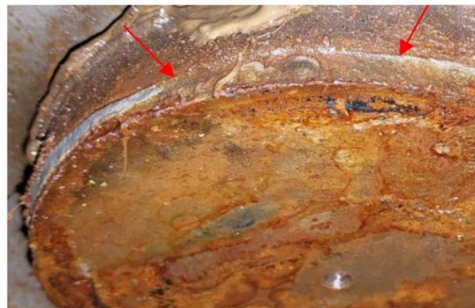
During mooring operations at the forward station when the 3rd head line (blue line in diagram below) was being heaved up using the warping head (the plan was to make it fast on a bollard to the aft of the failed roller) the deck stand roller pin parted from its base and hit a heater located just aft of this position.

There were no injuries. However, it is evident that any crew member standing in the line of fire of the damaged roller would have been seriously injured. The winch pulling force was 12 tonnes, the roller stand SWL was 33 tonnes.

- The mooring layout on this vessel was complicated and also did not follow accepted and recommended practice, which caused overloading of structures;
- The routing of the mooring line caused an increase of axial forces on the roller;

- On further investigation it was noticed that roller pin was already in the process of degradation and at least some part of the welded structure had already disengaged from the base. The roller had not been inspected thoroughly;
- Multiple turns over various fittings increase the complexity of the mooring systems and introduce additional hazards such as complex snap back zones and overloading of structures.

- Our member arranged to add to their Planned Maintenance System, dismantling and overhauling of deck stand guide rollers every third year;
- Ensure mooring plans use the most suitable and appropriate mooring arrangements;
- Avoid multiple turns which introduce complex snap back zones and additional hazards. Always discuss such risks as part of the daily planning and toolbox meeting;
- Be aware of your surroundings and of the line of fire.
