Malfunction of Kirby Morgan B17 side block non-return valve

Safety Flash Published on 29 July 2005 Generated on 28 January 2026 IMCA SF 09/05

Safety Notice # 1 of 2005
Defective One Way Valve Recall
July 12, 2005

Subject:
Circle Seal Controls, Inc. One-Way Valve Part P214-180.
Defective Valve Dates 12/04 thru 2/05

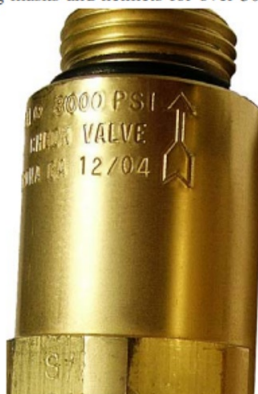
In the defective valves, small slivers of the Teflon wiper (used in these valves as part of the sealing mechanism) may be cut off the Teflon wiper and interfere with the poppet that seals the valve. When this occurs it is possible for air from the helmet or emergency gas supply to be lost through the valve if the diver's umbilical has been severed or umbilical pressure is lost for any reason. This could lead to the diver suffering severe personal injury, known as a "squeeze," or death.

Photo Caption: Please note the date stamp of 12/04 on the valve shown here. This is where to locate the date on your valve. All valves within the date range 12/04 to 2/05 should be replaced immediately.

If you have one of these valves on your helmet, or are carrying a valve like this as a spare, **DO NOT DIVE WITH IT!** Please return it immediately to KMDSI, or any of its dealers, for a free replacement. KMDSI can be reached at 1430 Jason Way, Santa Maria, CA 93455. Telephone 805-928-7772, FAX 805-928-0342. Email kirwin@kirbymorgan.com. Website www.kirbymorgan.com.
