Dropped object – Steel deck plate falls from pipelay tower

Safety Flash Published on 30 March 2021 Generated on 22 January 2025 IMCA SF 09/21

During testing and inspection of the pipelay tower on a vessel in dry dock, a large steel deck plate fell 9 m from the tower to deck

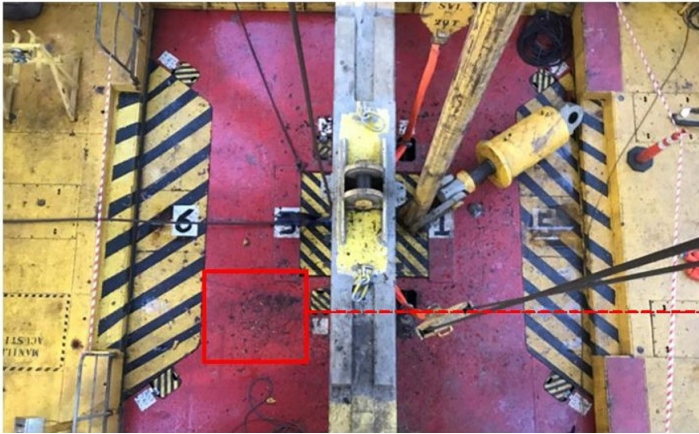
A large steel deck plate fell 9 m from a pipelay tower to deck.

The bolts securing the deck plate failed resulting in the deck plate upending and then falling to the deck below. The area below had been barriered off before work started. No-one was hurt.

On inspection it was noticed that the deck plate fixings were heavily corroded, with three of the four securing bolts providing no support.

- This deck plate and others found were not part of the original pipelay tower structure, nor on any vessel drawings.
- No change management or design engineering was carried out.
- Incorrect size and material grade of bolts were used.
- The deck plate was only supported on the rear section, and no support bracket had been installed underneath the plate where the technician stood.

Area on the working table where the deck plate landed

- Ensure all gratings, steel deck plates and their fixings installed at height are inspected as part of a routine inspection programme.
- Ensure equipment modifications are controlled through the change management process.
