## Riggers struck/trapped by pipe section

Safety Flash Published on 8 April 2022 Generated on 22 January 2025 IMCA SF 09/22

A pipe section being lowered into position unexpectedly moved sideways, striking two riggers.

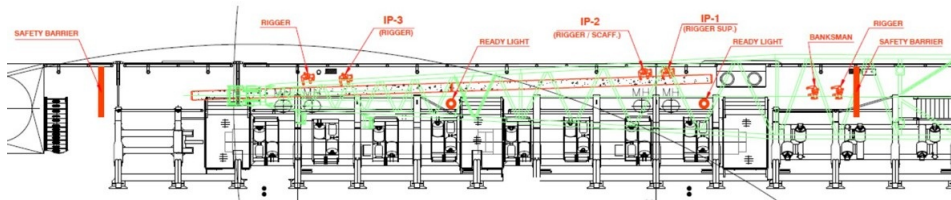
A vessel crane was lifting two 16 inch pipes of 24.4m length from a supply vessel to the pipelayer conveyor system. The second pipe section when being lowered into position unexpectedly moved sideways, striking two riggers, and trapping one between the suspended pipe and the vessel handrail. The rigger caught between the load and the handrail suffered a fracture in his back. Of the two who were struck, one suffered bruising to the ribs, and the other was physically unharmed.

On instruction from the banksman to lower the second pipe, it moved downward and away from the bumper bars. The pipe continued its horizontal motion, striking three riggers who were standing between the conveyor rollers and the vessel handrail. One rigger received a glancing blow. One rigger was momentarily impacted, and one rigger was caught between the suspended pipe and the handrail.

- The crane operator did not follow the banksman's instruction to lower but also introduced slew. The crane operator was new to the project crane operator position and this change in workload may have been a stressor.

- The rigging supervisor was directly involved in removing load rigging and protection and not in a stand-off position to oversee operations.
- No-one stopped the job: neither the banksman, supervisor nor crane operator, stopped the operation to ensure the line of fire zone was clear.

- The riggers remained in the line of fire during the movement of the second pipe section.
- The requirement to get out of the way while the pipe was raised was not specified in the task plan or the task risk assessment (TRA) but was discussed at the toolbox talk. Conflict was introduced through a verbal requirement reinforced in the toolbox talk to keep clear, whereas the task plan required riggers to be near the pipe to remove taglines.

- The repetitive nature of the operation, without any issues being experienced, may have reduced the risk perception of the potential line of fire hazard, making the riggers positions appear safe to them.

- Ensure that crane operation communications are clear, repeated and confirmed before load movements.
- Operations which have line of fire hazards should be checked to confirm the safe positioning of personnel is clearly defined, understood, and followed.
- Review zones where line of fire operations are regularly conducted. Confirm that where appropriate suitable barriers (permanent or temporary) are in place.
- Consider marking the deck as to identify no-go zones or restricted access.
- For repetitive work consider frequent toolbox talk sessions or introduce a pause to question the team to confirm they remain focused on the task and to reinforce the potential hazards and the controls to be maintained.
- Review repetitive high-risk tasks to confirm risk awareness is not decaying.
