Dry suit inflation installation onto a KM 37 helmet

Safety Flash Published on 9 June 2008 Generated on 20 January 2025 IMCA SF 10/08

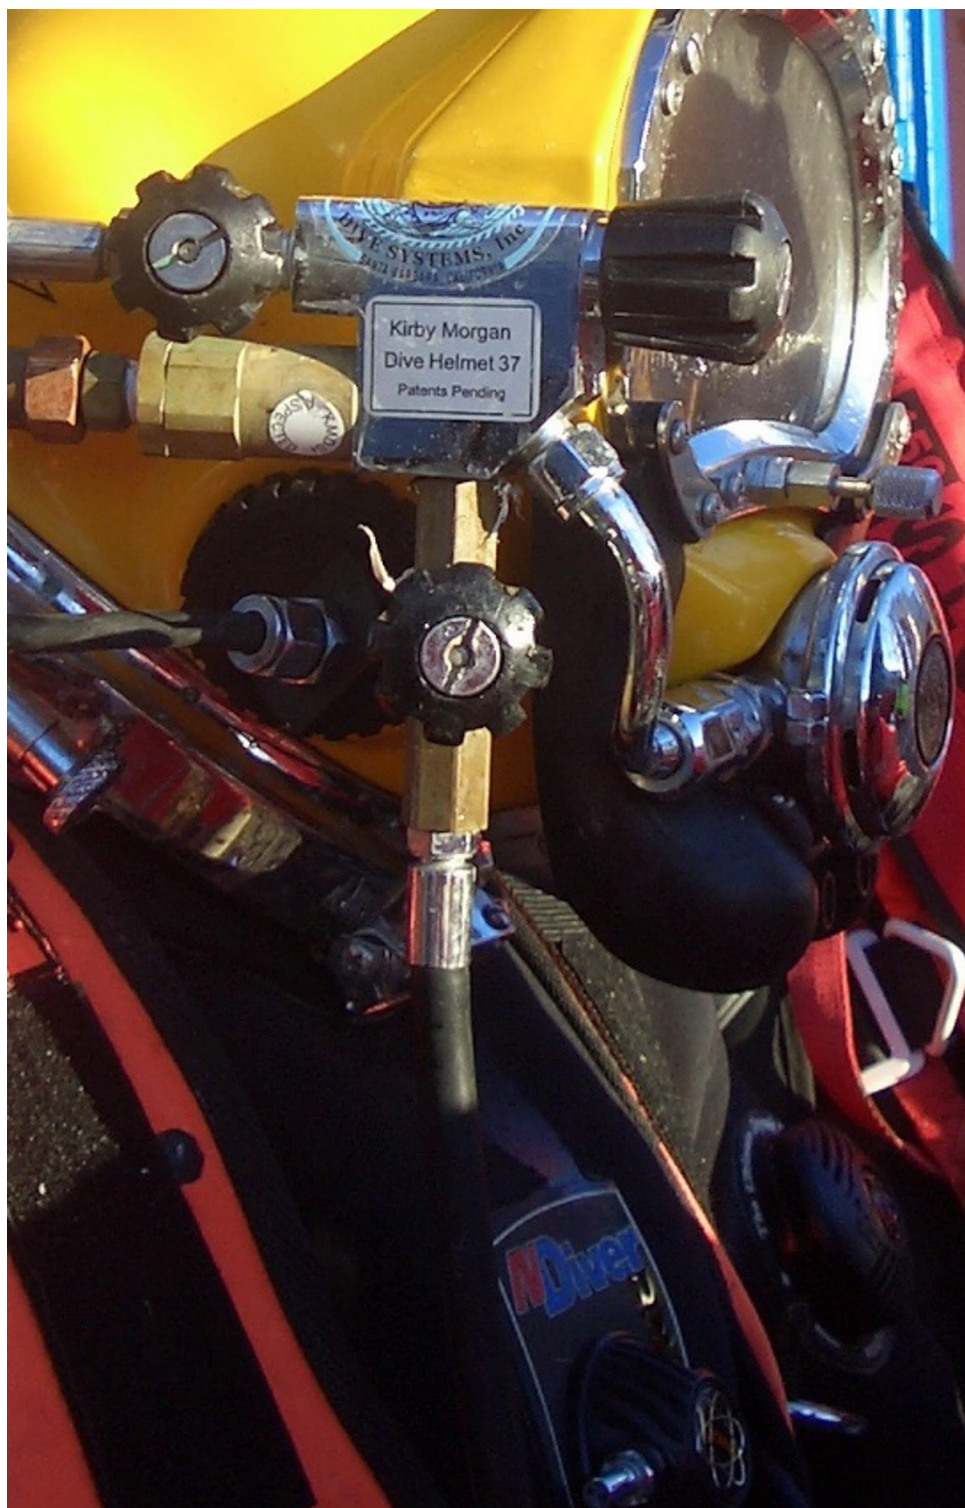
The practice of installing a dry suit inflation whip with modified fittings onto a KM 37 side block has been reported to IMCA.

- The modification to the side block assembly of the KM 37, shown in the photograph above, is not recommended.
- The leverage on the brass fitting is extremely high giving a high potential for breakage.
- The fitting at the bottom of the side block is a 3/8" straight thread fitting with an O-ring seal which is not designed to sustain this kind of leverage.

Members are reminded that an in-line valve is not deemed necessary by the helmet manufacturer, as long as a good quality and suitably approved inflator hose is used or the KMDSI restrictor adapter PN# 555-210.
