Dry suit inflation installation onto a KM 37 helmet

Safety Flash Published on 9 June 2008 Generated on 28 January 2026 IMCA SF 10/08

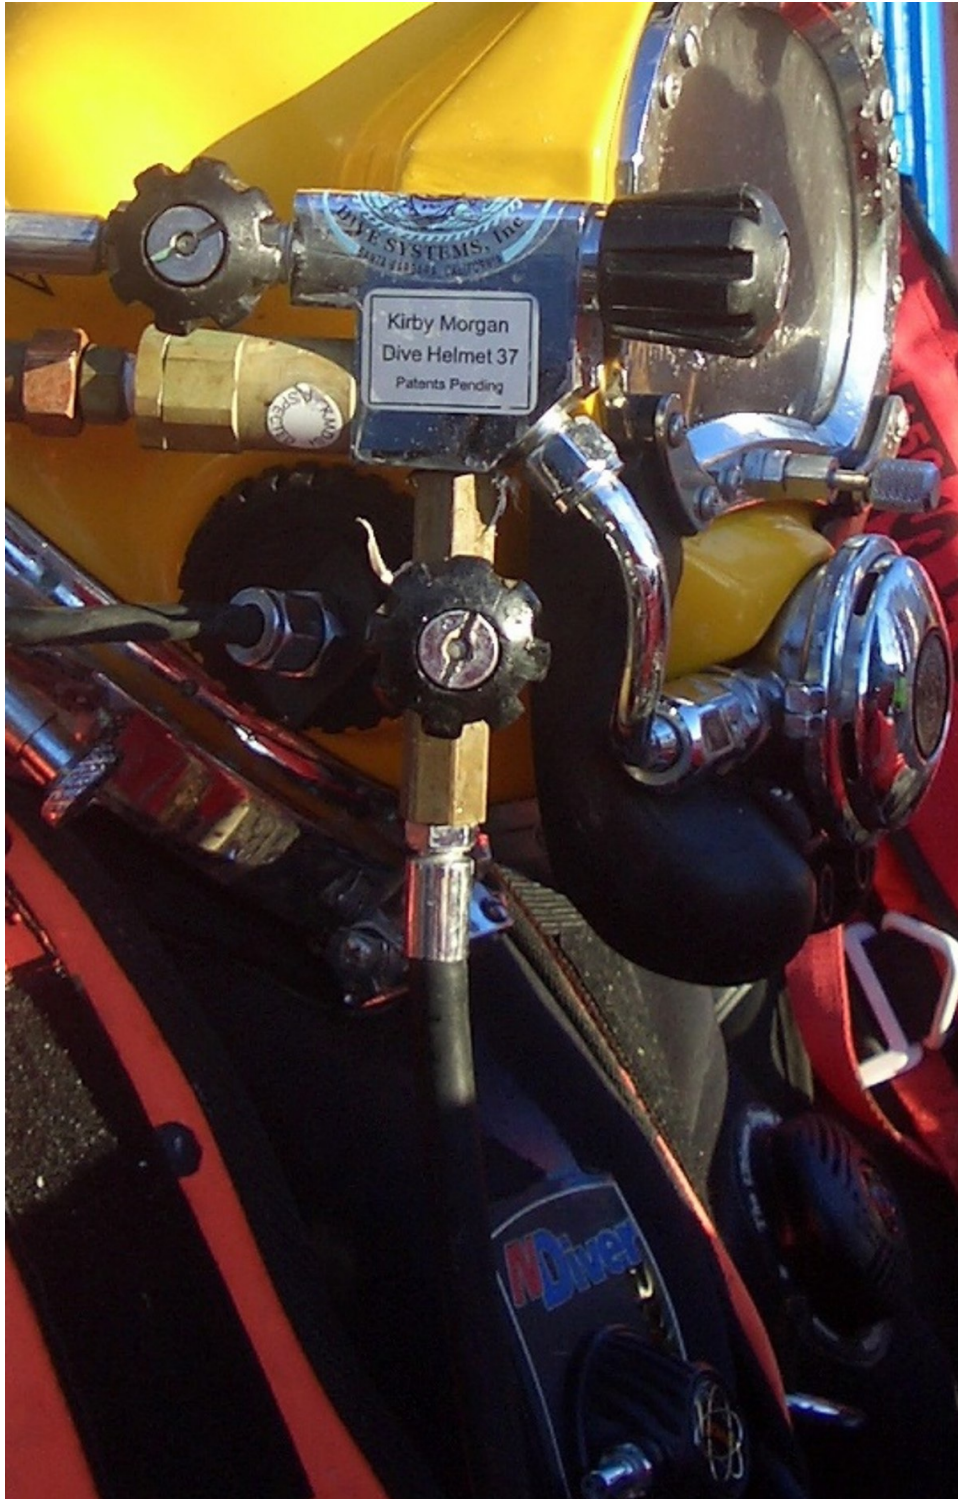
The practice of installing a dry suit inflation whip with modified fittings onto a KM 37 side block has been reported to IMCA.

- The modification to the side block assembly of the KM 37, shown in the photograph above, is not recommended.
- The leverage on the brass fitting is extremely high giving a high potential for breakage.
- The fitting at the bottom of the side block is a 3/8" straight thread fitting with an O-ring seal which is not designed to sustain this kind of leverage.

Members are reminded that an in-line valve is not deemed necessary by the helmet manufacturer, as long as a good quality and suitably approved inflator hose is used or the KMDSI restrictor adapter PN# 555-210.
