Lifeboat davit failure

Safety Flash Published on 10 July 2009 Generated on 16 March 2025 IMCA SF 10/09

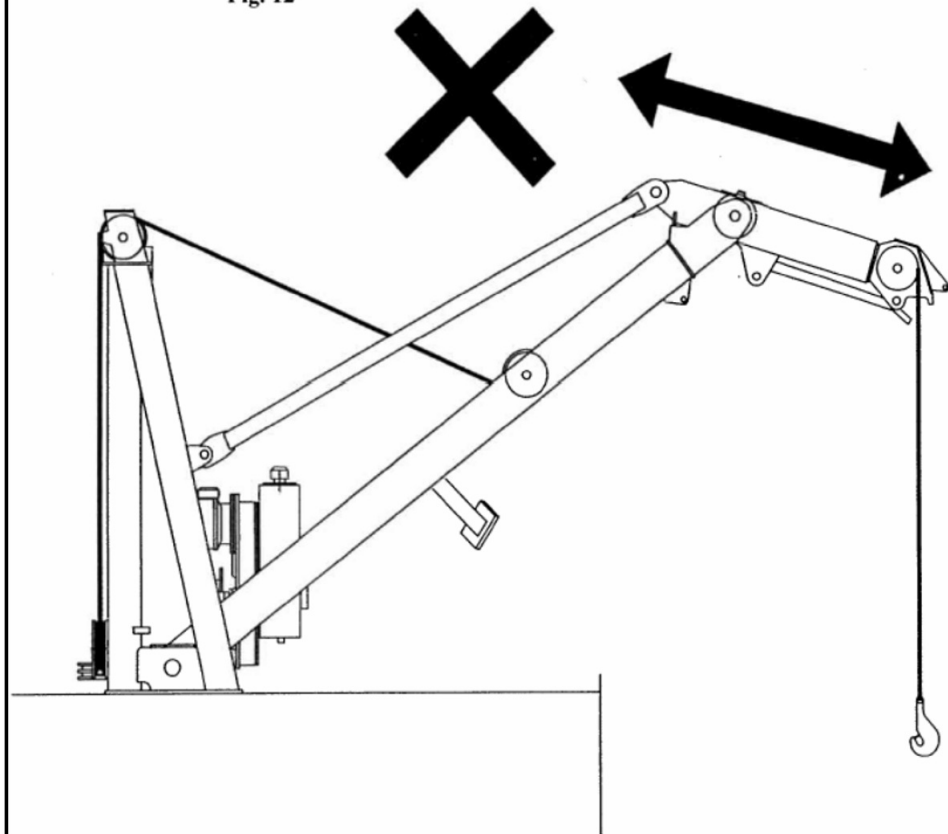
Fig. 12

NO movement of the DAVIT ARM is allowed without a minimum load of 500Kg on hook.

Hoisting and lowering of empty hook is allowed.
Serious damage can be caused if this warning is not followed.

*Suggested warning placard to be placed near
lifeboat operating station*

- The original equipment manufacturer's documentation for the davits should be consulted and appropriate operating instructions verified to ensure existing practices do not deviate from manufacturer-recommended launching practices, nor compromise the safety and operational integrity of the equipment.
- Davit launch/recovery operators should ensure that the davit is operated in accordance with the guidance provided by the original equipment manufacturer.
- Warning notices should be posted adjacent to each lifeboat operating station (see the diagram below).
- A thorough inspection of tilt plates should be included in monthly planned
