Safety Flash

Near-miss: Incorrect rigging of life raft hydrostatic release

Safety Flash Published on 12 May 2017 Generated on 3 July 2025 IMCA SF 10/17

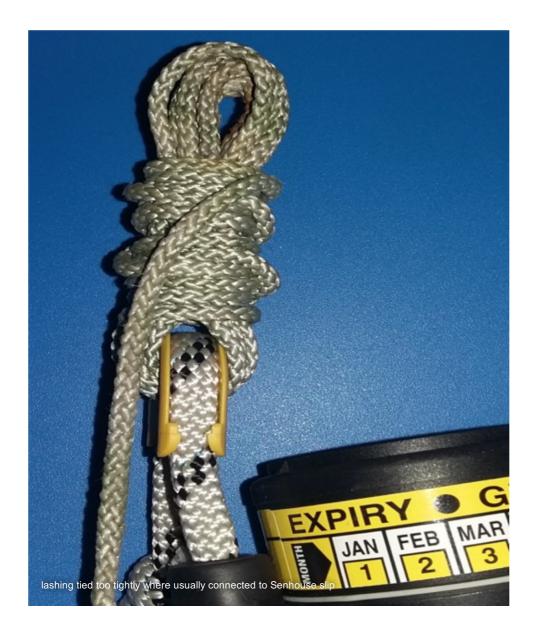
The incorrect rigging was discovered following the replacement of a life raft. It was noticed that if the collar on the Senhouse slip was lifted for life raft launch, it would not release the strap as the lashing that connected it to the hydrostatic release unit was tied too tightly, so the arm would not easily slip through and release.

This was due to the hitches in the lashing being carried on too far up towards the slip, not leaving enough room for the arm of the slip to move sufficiently.

- The Senhouse slip should not be attached through a lashing and should be directly attached to the hydrostatic release unit.
- Hydrostatic release units are fitted with a yellow plastic that aids the release of the Senhouse slip when released. If fitted through a lashing, this can create friction making the operator unable to launch the life raft safely.
- The lashing can still be used in the securing of the life raft, but in a different position. Care should be taken to ensure that the painter line is tied through the red ring on the hydrostatic release unit.
