Near miss: Vessel approach to wind turbine tower

Safety Flash Published on 8 April 2021 Generated on 16 January 2025 IMCA SF 10/21

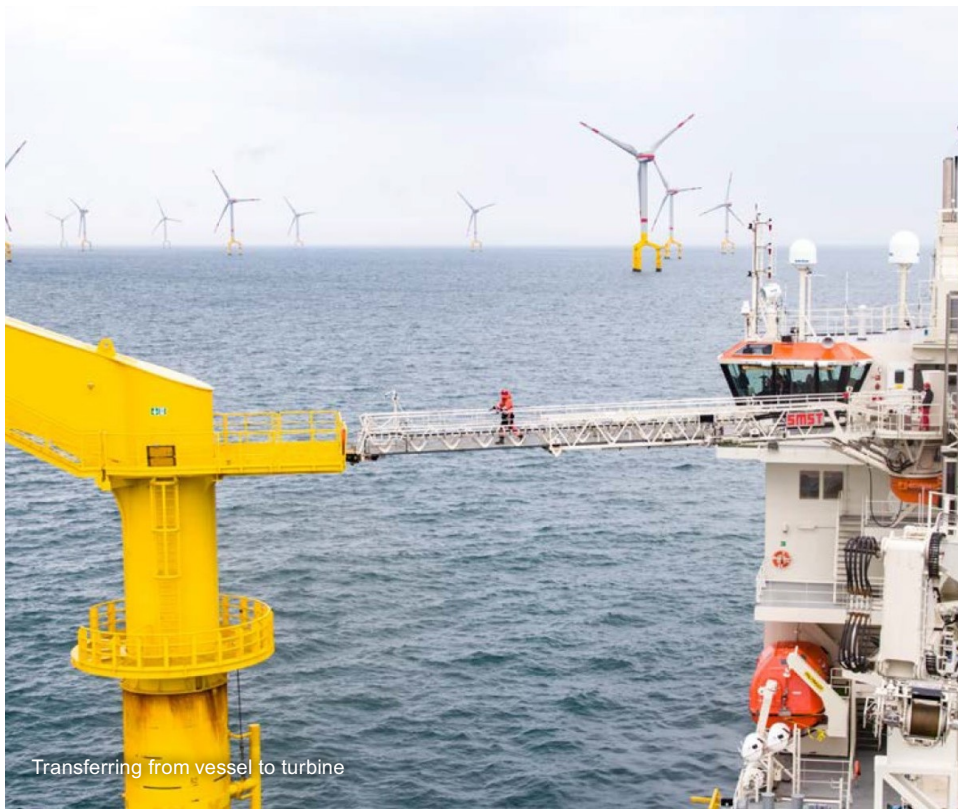
This was a similar situation less than one month later. There was a yawing turbine during docking. The turbine had stopped automatically because of a software error. The arriving crew initially reset the alarms before putting the turbine in STOP mode manually. However, directly after the reset, the turbine went to autonomous mode and started yawing before the vessel had moved out to the safe zone. The imminent danger was that the vessel could have been hit by the blades, which fortunately did not happen.

Investigations by the crew directly after the first incident event disclosed that the responsible person, working the software onboard the vessel, had not put the turbine in full STOP mode, but inadvertently put it in autonomous mode. It was suggested that the responsible person “*seemed a bit pressed that morning*”, causing him to forget to click the (second) tickbox in the software to not only put the turbine in autonomous mode but also in STOP-mode.

In addition, the turbine’s internal cables were at maximum twisted status, which occurs after a turbine has wound the maximum of 5 turns around the tower. A turbine in autonomous mode will automatically start yawing to unwind the cables. This was the initial cause of the near miss.
