MAIB: Blockage of fixed CO₂ fire extinguishing system pilot hoses

Safety Flash Published on 21 April 2022 Generated on 28 January 2026 IMCA SF 10/22

The UK Marine Accident Investigation Branch (MAIB) has published Safety Bulletin 1/2022 into a fire on board a roll-on/roll-off cargo ship in September 2021.

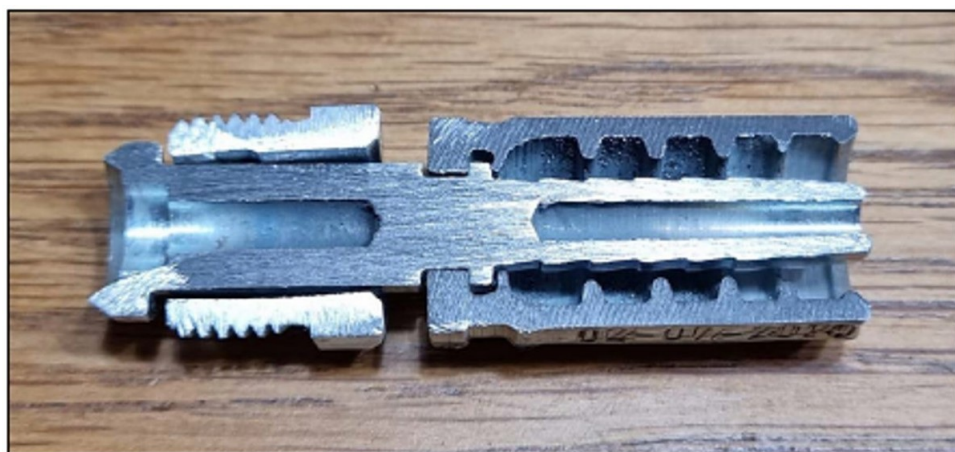
Investigation identified that one of the auxiliary engine room's CO₂ system pilot hoses was completely blocked. Subsequent examination and testing of the vessel's fixed fire extinguishing systems identified two other similarly blocked hoses. It was discovered that the pilot hose couplings had not been fully bored through during the manufacturing process. The testing process also identified several coupling leaks in the pilot lines.

Section through blocked CO₂ pilot hose coupling showing incomplete bore through the stem

All the affected hose assemblies had been supplied to the fire safety company by one supplier. The hose assemblies had been produced under the terms of the classification society type approval held by that one supplier. Although the type approval required each completed hose assembly to be pressure tested, there was no specific test that gas could pass freely through the hose assemblies.

The hose used in the assemblies was provided in accordance with the type approval held by that one supplier, but that supplier had purchased the couplings from another hydraulics supplier, who in turn had sourced the couplings from a different manufacturer.

- Ensure that crews are fully acquainted with the procedures for the manual activation of CO2 fire extinguishing systems in the event of the pilot actuation system failing.
- The fire safety company did not identify that some of the hose assemblies were blocked and that there were leaks in the CO2 system pilot lines.
- Neither the suppliers' quality assurance processes, nor onboard installation testing processes, identified that the hose couplings had not been fully bored through.
 - Amended procedures to incorporate a pneumatic flow test of the complete hose assemblies to verify that they are not blocked.
