Equipment damage: Dropped object from tiltable lay system

Safety Flash Published on 20 April 2023 Generated on 19 February 2026 IMCA SF 10/23

A bracket weighing 10.5 kg fell 16 m to deck.

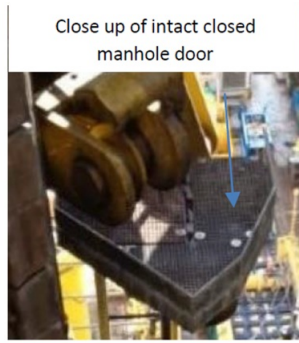
As the tensioner doors were being closed, the port side door made contact with a hinged bracket that was part of an inspection manhole gate which had been left open.

This resulted in the bracket, weighing 10.5 kg, dropping approximately 16 m to the work table below.

Dropped bracket

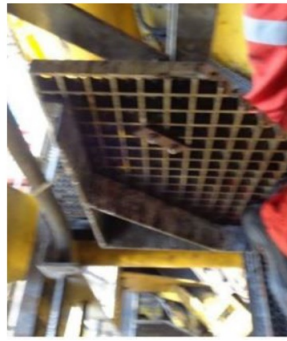
Before this event, the inspection manhole gate had been damaged in a previous unreported incident.

Subsequently some minor repair work had been undertaken which involved the removal of the grating from the gate/bracket. The hinged bracket was seized in the upright position and at the time it was not considered a dropped object hazard due to it being firmly secured to the TLS structure.

- The seized bracket was not fully repaired following the original incident.
- The latent hazard posed by seized bracket was not identified as a potential DROPS or as a clashing hazard.

(Right) Intact manhole door raised, showing bracket in upright position. The dropped object bracket was in similar position due to previous unreported incident.

- Although the first incident was recorded within the pipelay team handover notes, there was a failure to formally report it within the company incident reporting system – all damage incidents should be reported to ensure the correct level of investigation, and so that corrective and preventative actions are identified and implemented.
- The equipment design and layout failed to identify the clash points created when manhole gates were left in the open position.
