MAIB: LTI – fingers lost during mooring operations

Safety Flash Published on 4 June 2025 Generated on 28 January 2026 IMCA SF 10/25

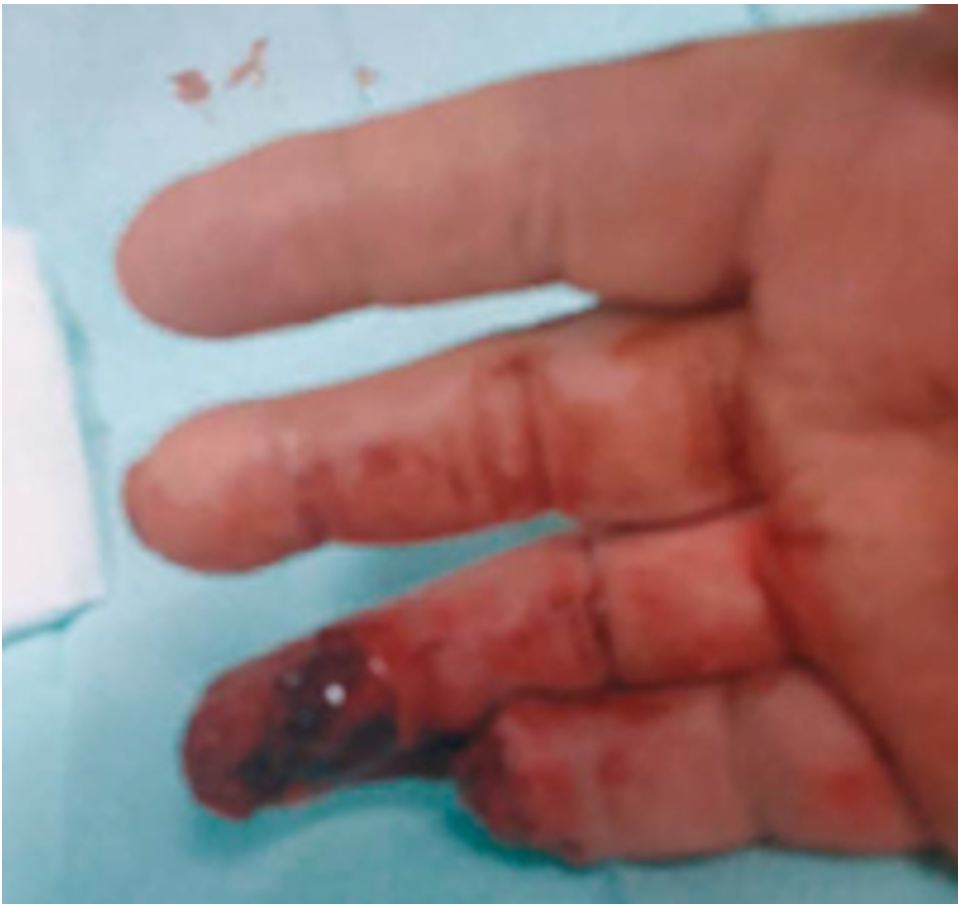
The river's current moved the tender against the barge and the mooring rope slipped off the cleat. As the crew member went to resecure it, the wash from a passing boat caused the tender to rise and fall. The crew member placed the eye of the mooring rope onto the cleat just as the tender descended, causing their fingers to be caught in the bight and crushed against the cleat.

The skipper heard a cry and saw the crew member holding their hand in pain. The accident severed the tip of the crew member's little finger on their right hand and badly crushed their right ring finger. The skipper raised the alarm and used the tender to transport the injured crew member ashore, where they were transferred by ambulance to hospital.

- Relative movement between a vessel and its mooring point creates a dynamic environment that requires crew members to be alert to entrapment risks when handling mooring ropes.
- Unexpected boat movements due to strengthening or receding waves, wind and currents can cause ropes to switch from slack to taut without warning: keep your fingers clear.
- Manage the risk: The difference in height between the two boats in this case increased the likelihood that the mooring rope would slip off the cleat and need to be resecured. Where this is a routine operation, and ropes cannot be run horizontally, conduct a risk assessment of the design and fitting of the cleats to prevent slippage.
