Finger trapped and injured while working on heavy equipment

Safety Flash Published on 28 May 2026 Generated on 28 May 2026 IMCA SF 10/26

A third-party technician suffered a pinch injury to the right index finger.

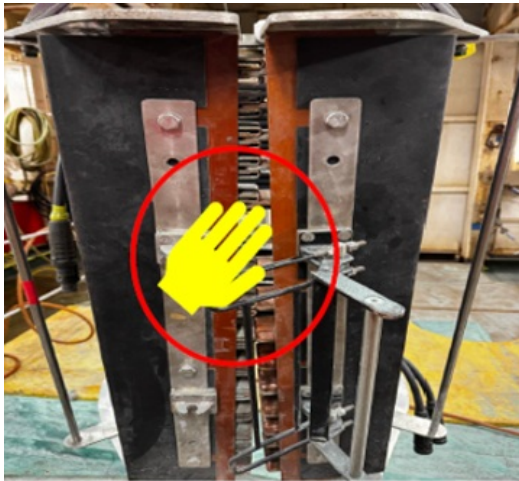
The incident – a Restricted Work Case (RWC) injury - occurred onboard a vessel while third-party technicians were conducting trials on pipelaying equipment. An Induction Heating Coil (IHC), suspended from a davit crane, did not open as intended. The technician, who was not part of the coating team, intervened to assist. During the intervention when the coil was subsequently prized open, the technician's hand was placed near the closing joint. The coil then closed suddenly, pinching the individual's right index finger.

Showing the pinch point on the Induction Heating Coil

- Change could have been managed better: The task was moved to a different work environment without a complete risk review, preparatory checks, or a formal Management of Change (MoC) process.
- Equipment could have been better designed: The lifting configuration did not fully align with the operational environment, and restricted space limited safer alternatives. Visibility of safety signage and labelling required improvement.

- Use of generic rather than specific documentation: generic documentation was used instead of task-specific controls. The lift was incorrectly classified, and the designated rigging was not used.
- Supervision: Roles and expectations across involved teams were not clearly aligned, which resulted in gaps in supervisory oversight.
- There were gaps in the contractor's equipment assurance: Required compliance checks and supporting maintenance records for the contractor-supplied equipment were not available.

- Ensuring task-specific risk reviews, and use of the Management of Change process when the work environment, set-up or method of work is changed.
- Improved equipment design visibility and usability, ensuring controls and labelling are clear and safe to operate.
- Ensured appropriate levels of supervision to cover multiple, complex or simultaneous tasks.
- Ensured that Short Service Employees are given adequate support and supervision.
