Grinding disc with defects

Safety Flash Published on 27 October 2011 Generated on 25 April 2025 IMCA SF 11/11

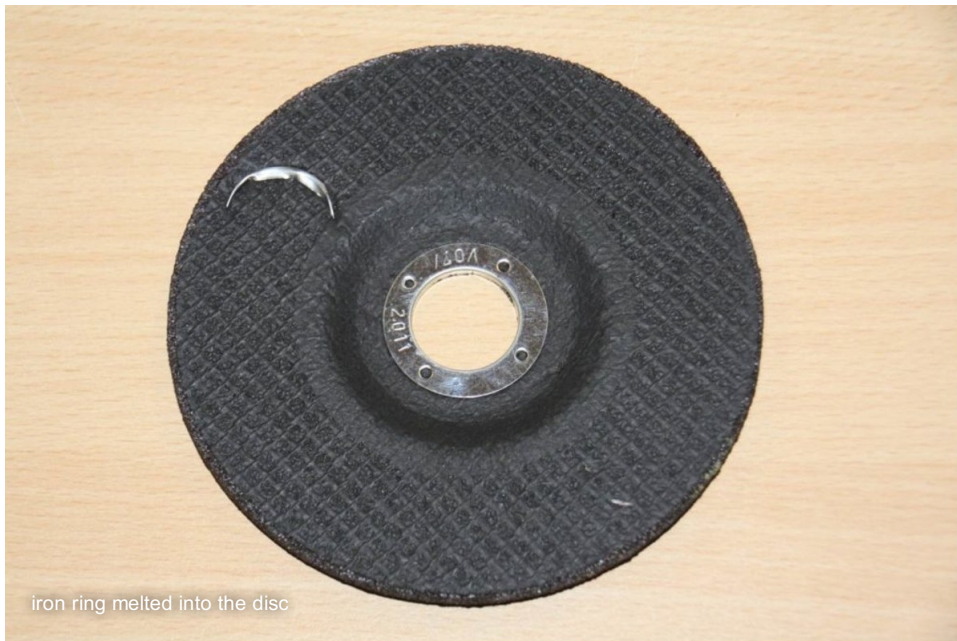
When grinding, the defect could have resulted in the disc cracking leading to possible serious injury or damage. The defect seemed to be a disc steel inner ring that had melted into the disc during fabrication.

It was noted that safe grinding starts and ends with a visual inspection of the grinding equipment. The welder followed recommended process and identified a defective disc before it was used.

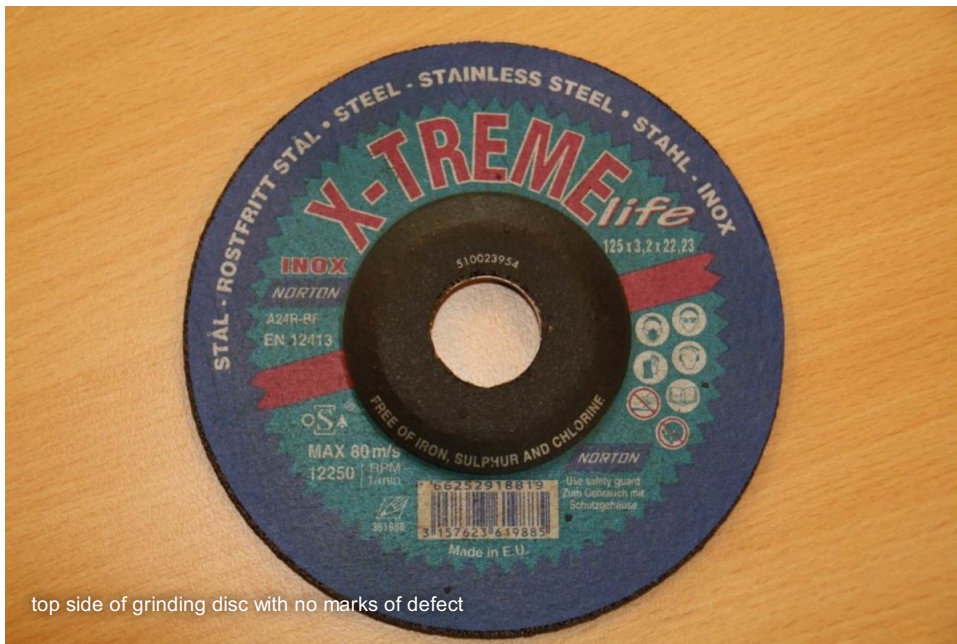
top side of grinding disc with no marks of defect
