Dropped object: Lay tower adjuster leg pin

Safety Flash Published on 22 May 2017 Generated on 24 January 2025 IMCA SF 11/17

The securing pin from a tiltable lay system (TLS) adjuster leg, weighing 600 kg, fell 16 m to deck.

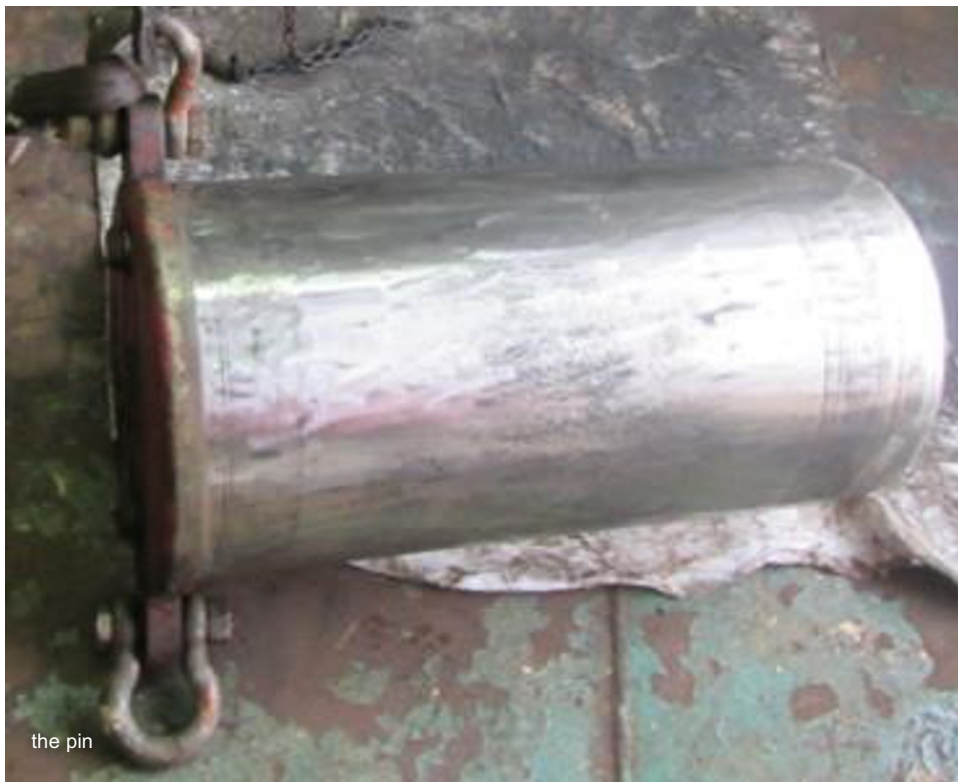
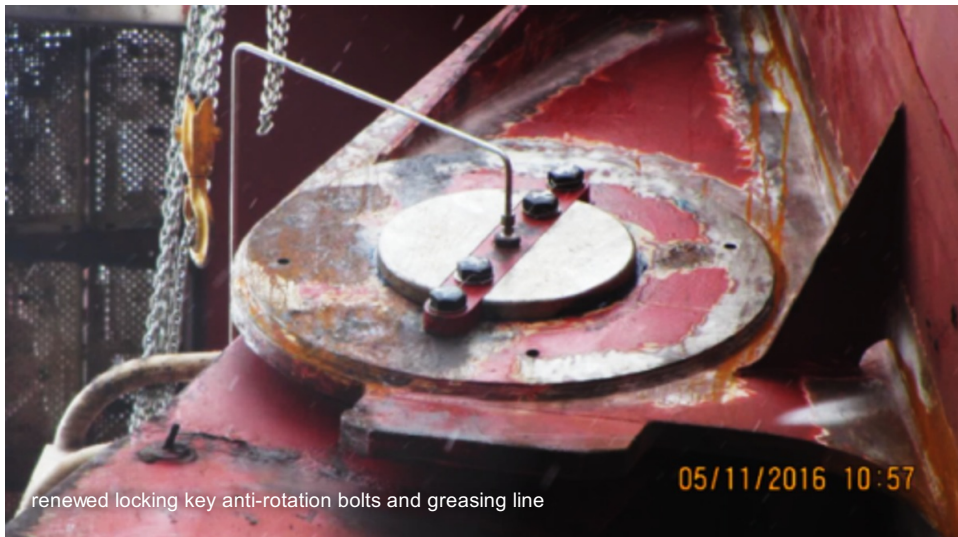
The incident occurred when the keeper plate bolts slackened off. No-one was in the immediate area below the adjuster leg at the time of the event and no-one was injured.

right: close-up of the adjuster leg housing (with bolts, keeper plate and pin missing)

- Investigations found that the planned maintenance and inspection regime was inadequate and unclear.
- During transits the tower was at times kept in operational position which could have allowed excess movement of the pin due to reduced load and increased dynamic movement.
- The design made it difficult to lubricate the pin adequately which may have caused excess friction.

- Following discussions with the manufacturer, the vessel returned to port for investigation, and during the transit to port, Structural Non-Destructive Testing (NDT) of pin connecting parts was undertaken on both legs to verify sufficient load capacity and seaworthiness.
- Adjuster leg pin put back in place and increased diameter anti-rotation locking key bolts were installed to provide additional bolt shear strength, as per manufacturers recommendation.
- Additional temporary bolt locking mechanisms (Loctite and locking wires) were installed on both adjuster leg pins locking key bolts to ensure vibration would not loosen the bolts before the permanent solution was ready.
- A check was made throughout the tower, of the tightness of all critical bolts and pins; new pin, bushing and lubricating lines were installed.

- Tower to be in survival mode position during all transits according to the manufacturer's recommendations.
- Planned maintenance requirements updated and clearly defined for accurate inspection criteria for critical pins and securing mechanisms.
- Bolt locking mechanisms installed in TLS critical pins (adjusters and TLS pivot) to ensure vibration will not loosen critical bolts.
