High potential near miss: worker inadvertently lifted by crane (Marine Safety Forum)

Safety Flash Published on 4 June 2018 Generated on 28 January 2026 IMCA SF 11/18

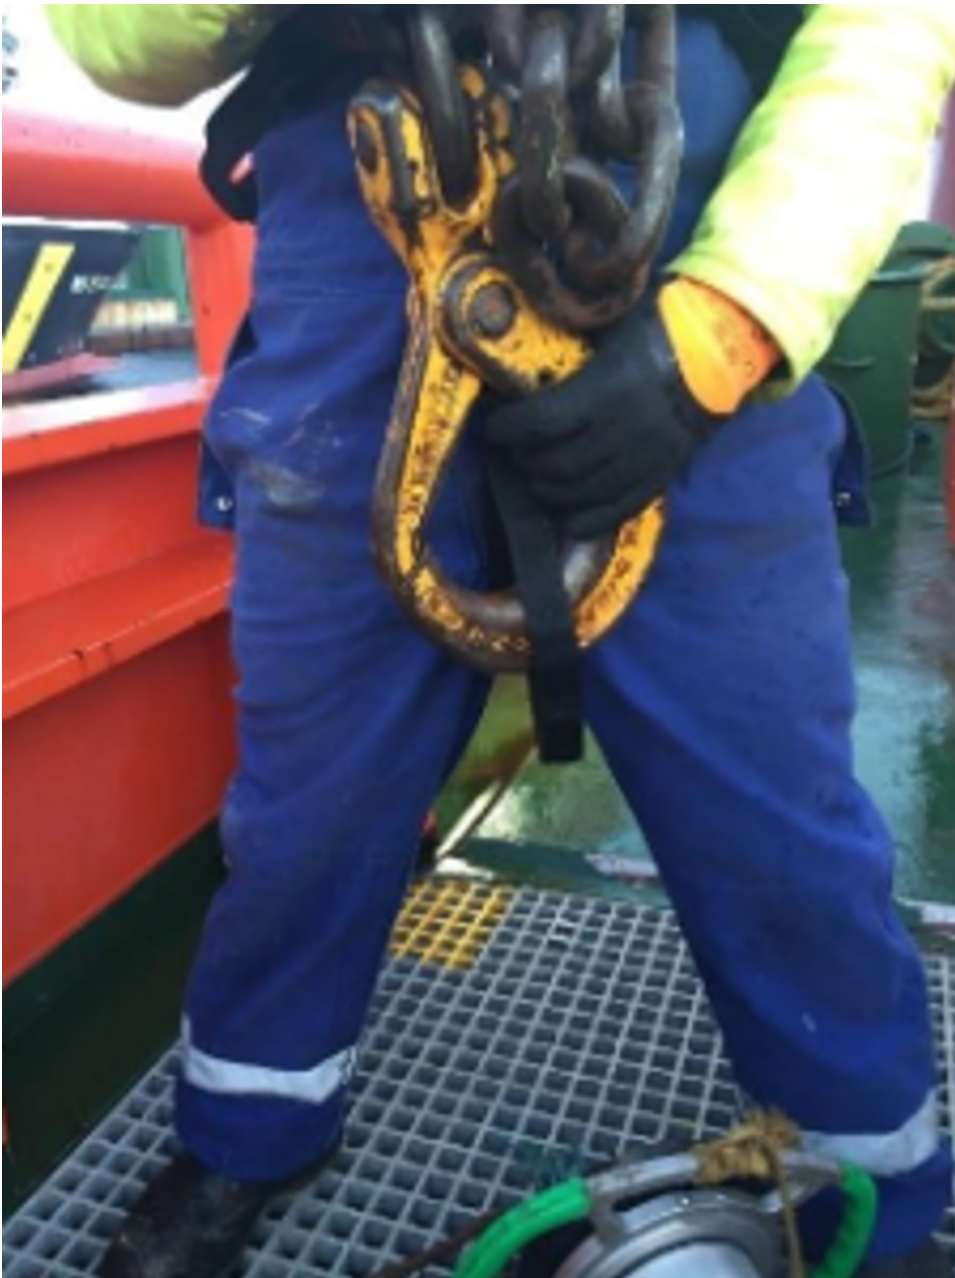
As the hose landed on the vessel deck, an AB went to release the hook from the lifting sling. While slightly bending forward and down to clear the hook, the crotch strap of his lifejacket formed a larger than normal bight. As the AB released the hook, it was incorrectly placed inside the bight and as he returned to the upright position the hook was caught. Unfortunately, the AB did not notice this, and signalled to the crane operator to 'hoist'. This resulted in the AB being lifted above the deck and out over the side of the vessel. The AB's immediate reaction was to hold onto the pennant wire to keep tension off the crotch strap. The crane driver and second AB quickly became aware of the situation and were able to land the AB safely back on deck. The AB remained suspended for around 11 seconds and was unharmed.

- The crotch strap on the lifejacket was not suitably tightened on this occasion. A change in body posture created a larger than normal 'bight' which allowed the hook to become attached.
- The hook and lifting sling landing directly on the deck of the vessel.
- The AB's posture during the disconnection of hook.
- A momentary lack of awareness on the actual location of the hook, i.e. left open, close to the body.

- Hook awareness – ensure hook is clear of the body and any snagging hazards.
- Buddy check during the TBT before work starts.
- Raise awareness across the fleet for all lifting operations.

- Discuss amongst the industry and fleet deck crews on a suitable “pause point” before giving signal to crane operator.
