Maintenance and painting – two incidents

Safety Flash Published on 4 May 2022 Generated on 23 January 2025 IMCA SF 11/22

Incident 1: Material failure during lowering of lifeboat

Incident 2: Damaged sheave due to main hoist high hook failure

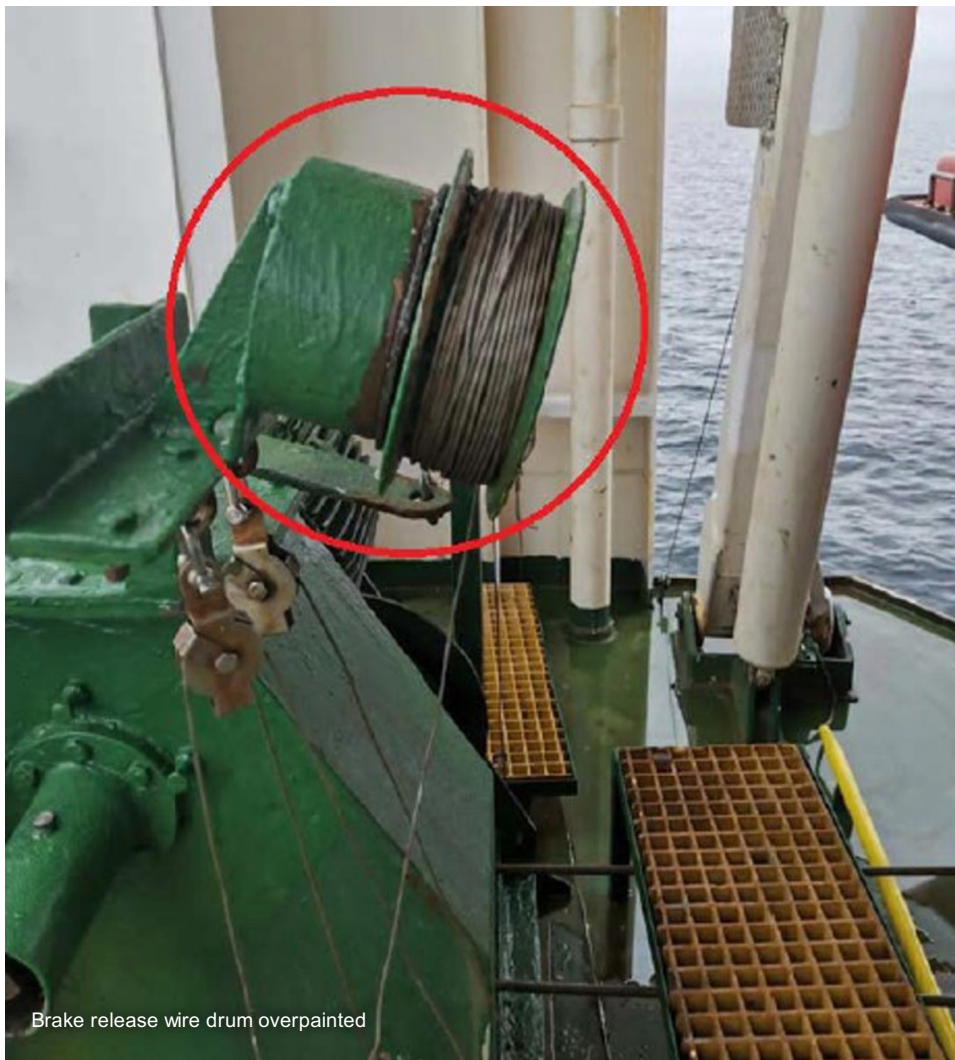
Photo 1

During lowering of a lifeboat, a small shackle broke. The shackle held the upper sheave guiding the brake release wire, resulting in the sheave falling down on top of the lower sheave. This caused the brake handle not to fall into brake position, with the consequence that the lifeboat did not stop lowering but kept on going down.

Investigation showed that the brake release wire drum was stuck/not turning, apparently due to there being an excessive amount of paint (see illustration) applied during the recently done maintenance. Once the paint was removed, the drum could be easily moved by hand.

- The damaged sheave was reshaped. Thorough examination of the sheave surface and inspection by means of dye penetration testing showed that there were no cracks.
- Ensure close monitoring the crane movements after each order given and when working near any of the crane limits.
- Test alarms after maintenance on the crane.
- After maintenance/painting check that all equipment parts are still movable and fully operational.
