## Lock out/Tag out and unauthorised electrical connections/disconnections

Safety Flash Published on 18 June 2025 Generated on 28 January 2026 IMCA SF 11/25

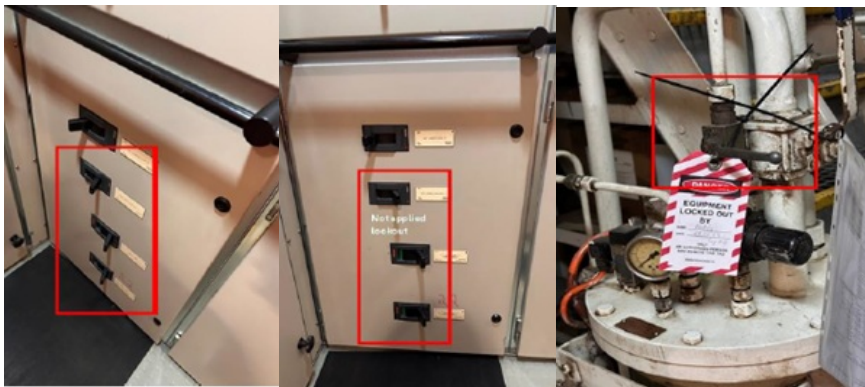
During a walkaround audit of a vessel engine room, problems were observed with the Lock Out/Tag Out (LOTO) process, It was observed that electrical equipment was switched off, but LOTO was not applied in place. Also, for the mechanical isolation, the locking device was not in place, though the mechanical valve was closed and tagged out.

*Case 1: No LOTO applied on the main electrical switchboard*

*Case 2: No mechanical valve lock out was applied on the equipment*

- **Case 1:** Lock Out/Tag Out (LOTO) was not applied on the electrical switchboard by ETO during repair of AHT hydraulic pipeline. Though the main switchboard was switched off and emergency release button was activated from the bridge;
- **Case 2:** Valve lock out (mechanical isolation) was not applied on the hydraulic pipe, though the valve was physically closed, and isolation tag was applied on the valve;
- Lack of Control of Work and Isolation process onboard- the correct isolation process was not applied by the responsible personnel;
- A suitable LOTO device was not available onboard for the electrical isolation

points on the main switchboard for AHT hydraulic pipeline, although a previously email instruction had been sent to all fleet vessels to ensure sufficient LOTO devices were available onboard.

- Simply switching off a circuit or closing a valve does not guarantee complete isolation - unexpected reactivation can occur due to system malfunctions, human error, or mistaken assumptions. A proper LOTO process ensures that energy sources remain isolated until the work is completed and verified safe for reactivation;

- LOTO should be fully implemented for all maintenance tasks- Every maintenance or repair activity involving hazardous energy should follow a thorough LOTO procedure, regardless of the presence of physical barriers like switch-offs or valve closures. The absence of LOTO devices or failure to apply them properly can lead to severe injuries, equipment damage, or even fatalities.

- Ensuring availability of suitable LOTO devices onboard - the absence of an appropriate LOTO device for the main switchboard highlighted a critical gap in safety preparedness. Proactively verify that all necessary LOTO devices are onboard and suitable for all potential isolation points.
