Lift bag lost when rigging parted

Safety Flash Published on 17 August 2009 Generated on 24 January 2025 IMCA SF 12/09

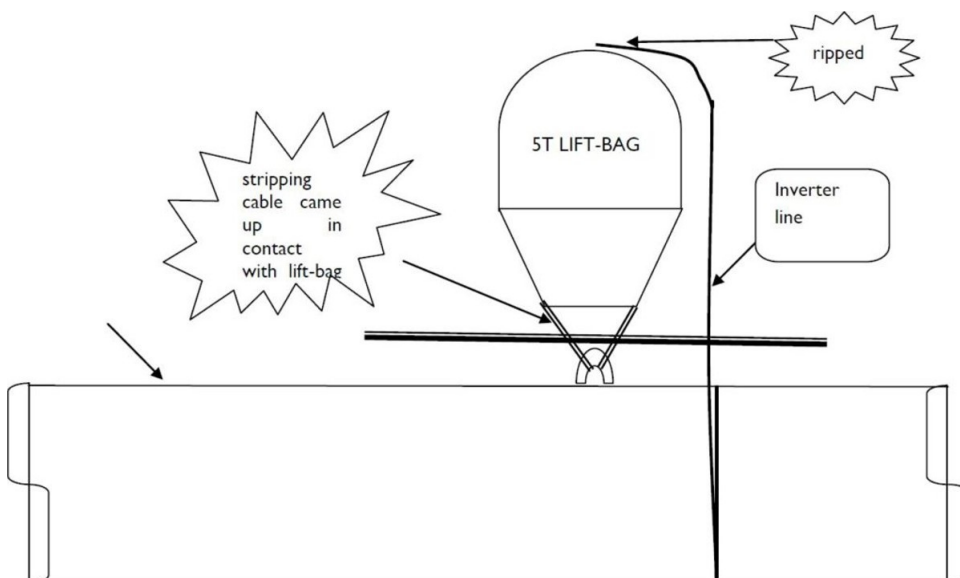
Schematic diagram of pipeline and lift bags illustrating incident

Further inspection revealed that the webbing straps of the bag had been cut through when the strip-out wire was pulled at an acute angle across the plane of

the pipe relative to the bag. It was also discovered that the inversion line had pulled the attachment points away from the crown of the bag. These strops remained secured to the inverter line which in turn remained attached to the pipeline.

It was further determined that the strops at the top of the bags used for attaching the inversion lines were intended for handling purposes only and were not designed as inversion line attachment points.

- When feasible, remove lift bags in advance of potentially conflicting tasks.
- Re-circulate existing safety recommendations, including IMCA Safety Flash 07/07.
- Check identification and marking of dedicated inversion point attachments and lift bags.
- Amend work instructions to include a reference to the inclusion of purpose-built and labelled inversion line attachment points for all future rentals/procurement of this equipment.
- Consider retrofitting inversion attachment points to bags not currently having this feature.
