Near-miss: Fire hazard from leaking fuel supply line

Safety Flash Published on 25 May 2017 Generated on 16 January 2025 IMCA SF 12/17

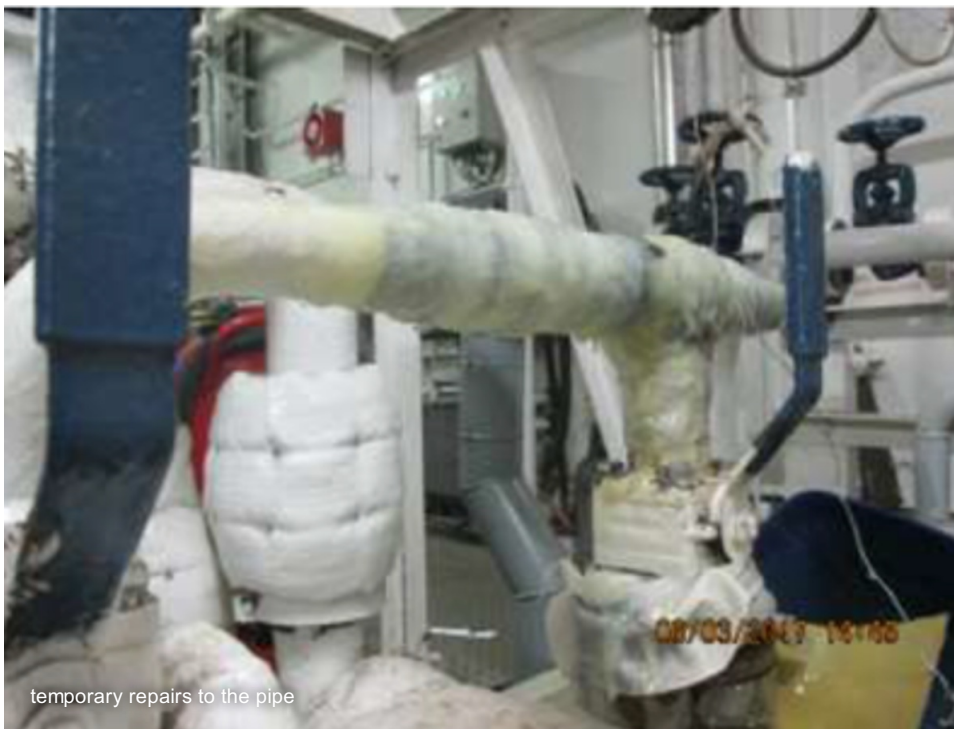
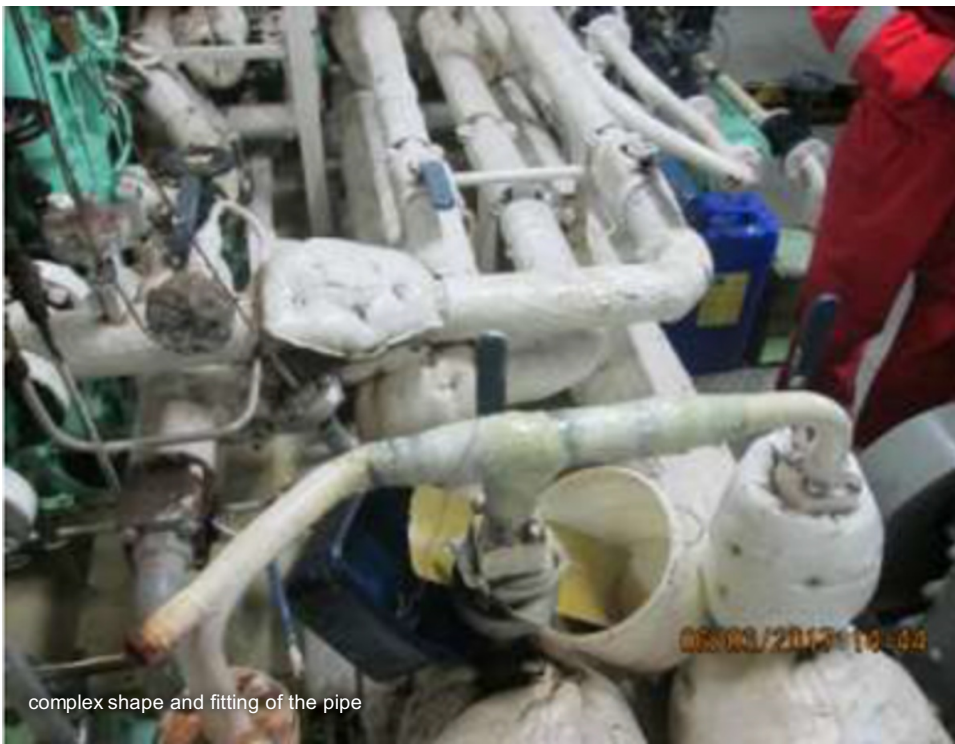
The Chief Engineer was called to engine room with a report of a leak on a low pressure fuel supply line supplying both main engines. Upon arriving in the engine room and assessing the situation, a temporary repair was effected, due to being unable to isolate the pipe. Self-amalgamating tape was used to reduce the leak to a weep and then fibre-glass resin and bandage was applied, to try and seal the weep.

temporary repairs to the pipe

The **immediate cause** was found to be a failed weld on a T-piece of the pipe.

The **root cause** is believed to be the age of the pipe, an original fit from the vessel's construction, incurring natural degradation over time.

- The leak was discovered early as a result of due diligence and good watchkeeping, which allowed for a controlled temporary repair.
- The vessel notified shore management as soon as possible after the incident, providing detailed Incident reports, supporting information and photographs.
- Vibration, owing to the proximity of the main engines, is going to be an issue with equipment of this sort. Engineers should maintain awareness of equipment shortcomings and manufacturing design weaknesses.
- As such failures cannot always be predicted and vessels should always carry appropriate pipe repair solutions such as plastic steel, fibre glass resin, pipe repair clamps etc.
